Structural Condition Assessment – Overhead Utility Bridge  
282 Ontario Street, St. Catharines

February 3, 2026

Our file: 26013

**Re: 282 Ontario Street, St.Catharines – Overhead Utility Bridge Structural Condition Assessment**

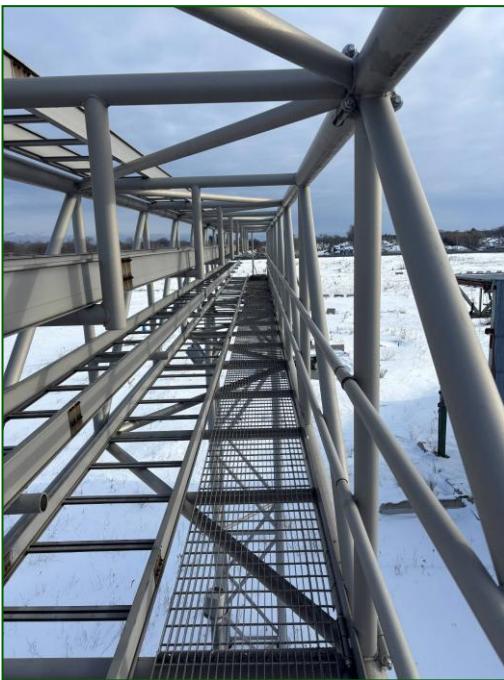
**Photo 1 – Walkway and Guardrails**

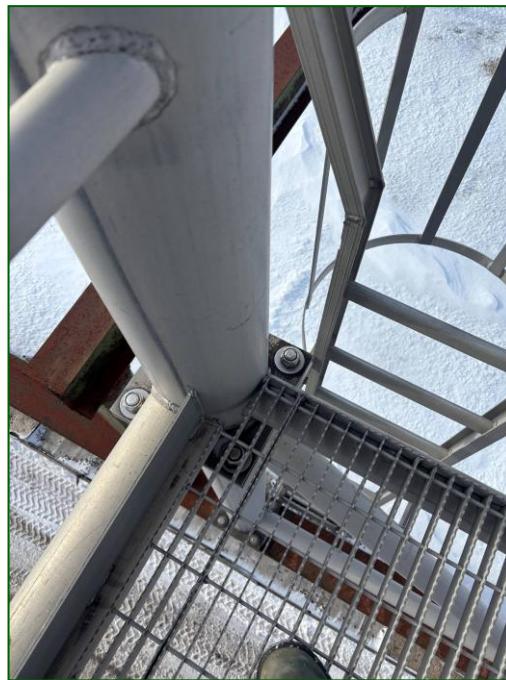
**Photo 3 – West End Access Ladder**

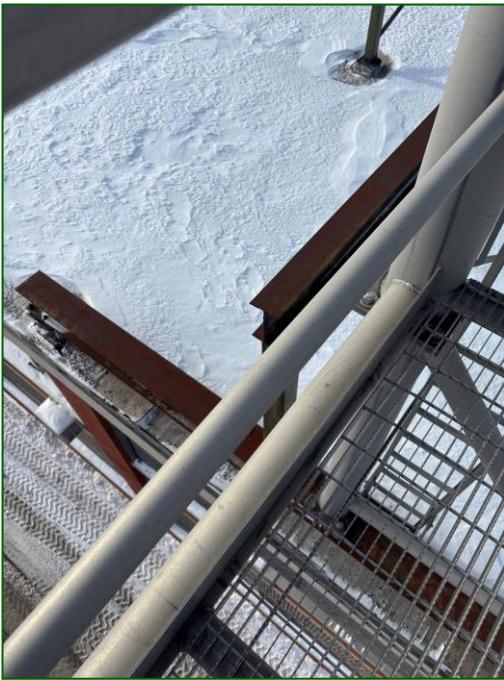
**Photo 2 – West End Support**

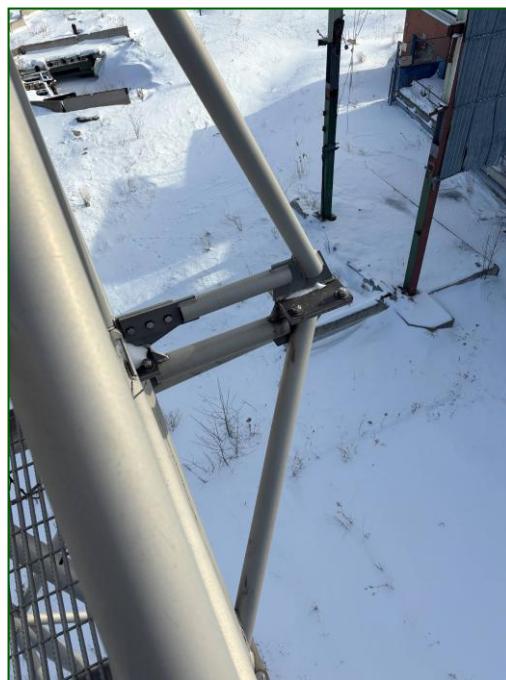
**Photo 4 – East End Support**

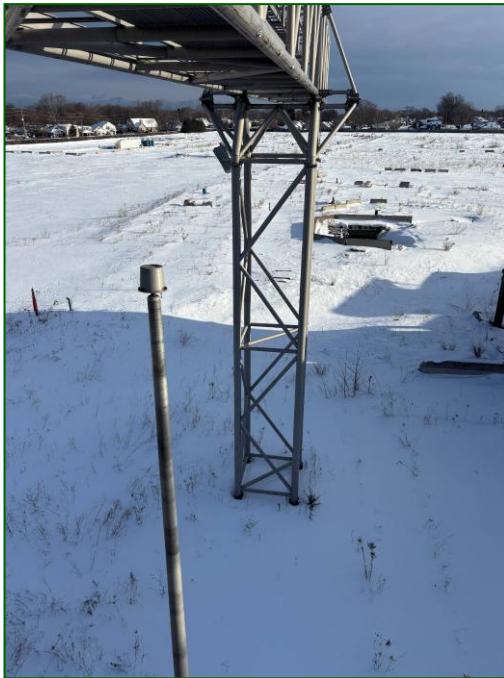
- The existing bridge foundations were not visible at the time of inspection.

**Photo 5 – East End Support and Foundation**

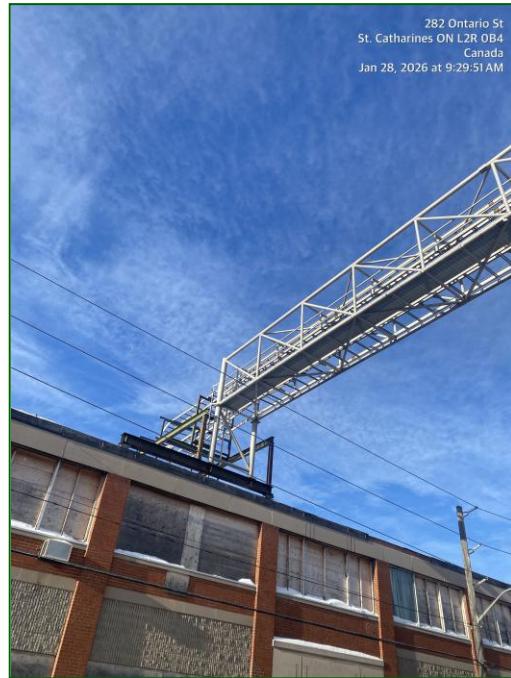
- The west end of the bridge bears on the existing steel framing of the former services bridge located on the roof of the existing building west of Ontario Street. (Photo 7).

**Photo 7 – West End**

In the event that the existing building west of Ontario Street is demolished, the bridge is to be removed prior to any demolition activities.

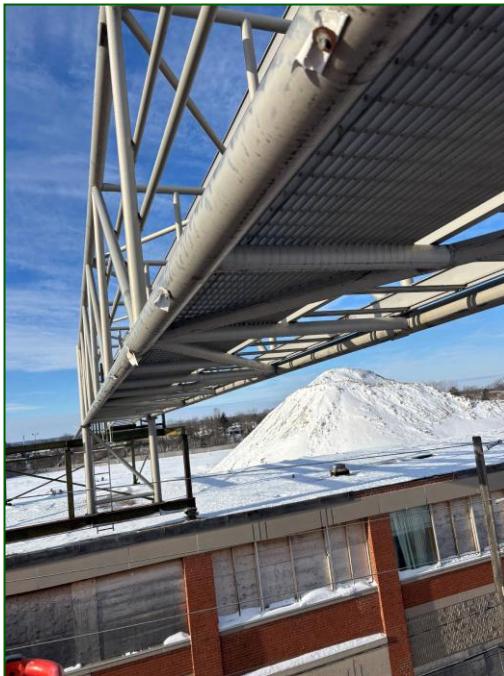
- The bridge frame is constructed of circular HSS steel members, with the primary horizontal chords consisting of 6" diameter tubes and the vertical and diagonal bracing consisting of 3.5" diameter tubes.

**Photo 6 – Typical Truss**

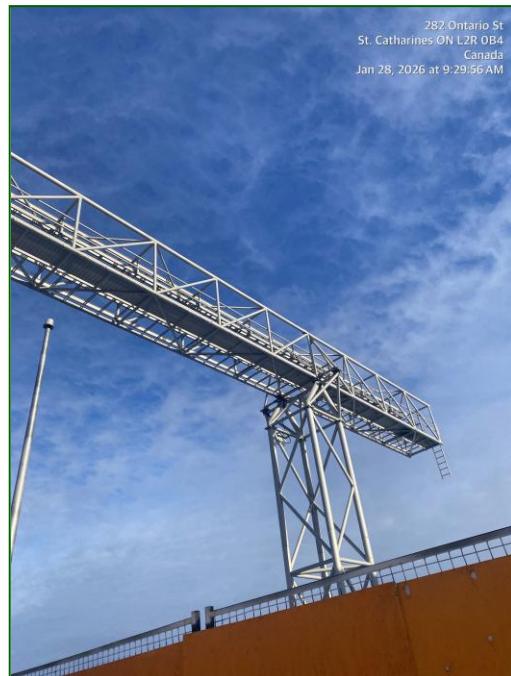
- There were no visible signs of rust, deterioration, or section loss on the bridge.
- The bridge consists of 16 panel points, each measuring approximately 98" wide and 84" high. There is a splice connection between the 7<sup>th</sup> and 8<sup>th</sup> panel points from the west end. The bridge is supported by a freestanding steel braced frame tower between the 12<sup>th</sup> and 13<sup>th</sup> panel points, beyond which the bridge cantilevers (Photo 8).

**Photo 8 – East End**
