CITY OF ST. CATHARINES

ST. CATHARINES YMCA BUILDING CONDITION ASSESSMENT & STUDIES

JULY 24, 2024

PROJECT NO.: CA0036719.6657
DATE: JULY 30, 2024

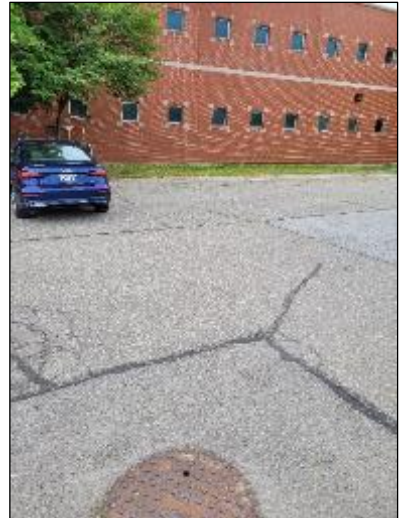
The alligator and longitudinal cracking is more predominant in low areas (i.e. areas where parking lot is graded to the center for drainage, for example on the north and south sides of building), which suggests the seam between two areas where asphalt put down let water in and that the alligator cracking resulted from water infiltration and not a result of base failure. It is noted that the storm sewer mains are not installed under these low points, so failure at the low areas is not a result of trench conditions.

Photo C9:
North Parking looking south from STMH 5. Alligator cracking outside patch at STMH but significantly reduced cracking closer to the curbs. Sealed longitudinal crack in background, 5.5 m north of curb.

Replacement of parking lot asphalt by milling and placement of 55 mm Medium Duty Binder Course asphalt with maximum 20% RAP and 50 mm of HL 3HS asphalt. Opinion of probable cost for repaving the parking lot is included in Appendix G, Cost Feasibility Report.

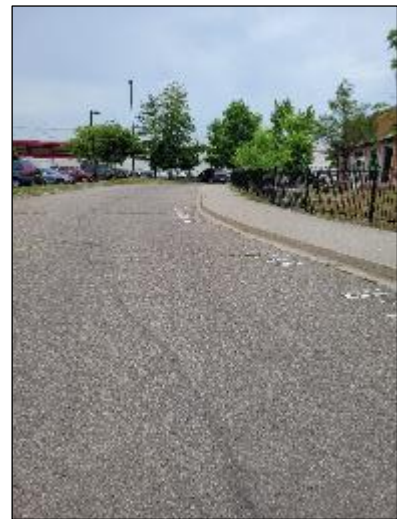
Photo C15:
South Entrance Looking West – Better condition than to east. cracking, cracks sealed and sealing failing, asphalt erosion.

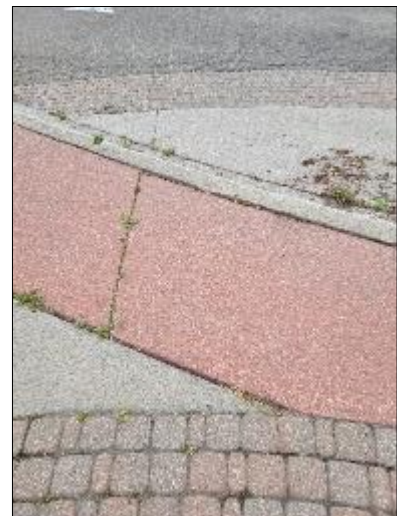
Photo C23:
East Entrance – Sidewalk cracked,
concrete and interlocking brick settled
relative to each other and curb.

- Level settled sidewalks.
- Level interlocking block that has settled relative to adjacent concrete.
- Rout and grouted or the cracked sections sidewalk or removed and replace.
- Remove and replaced cracked and heaved sidewalk at northeast corner of building.

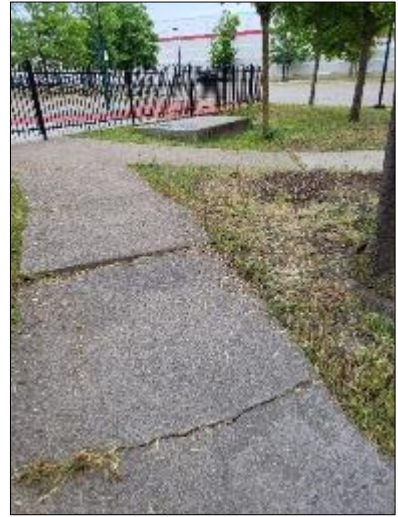
The sidewalk is heaved and cracked at the north-west entrance and represents a trip hazard.

Photo C26:
Northeast Entrance to Splash Pad:
Sidewalk heaved and broken,
differential settlement.

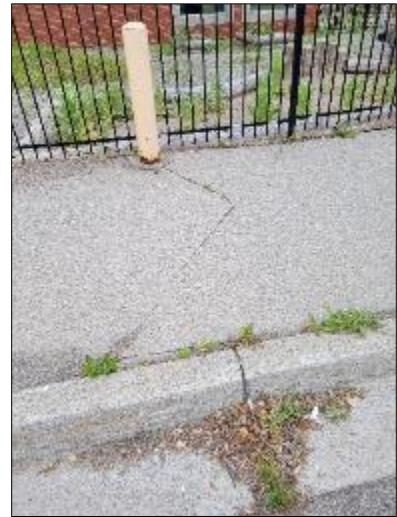
Photo C29:
West Playground Area – Cracked
sidewalk, differential settlement.

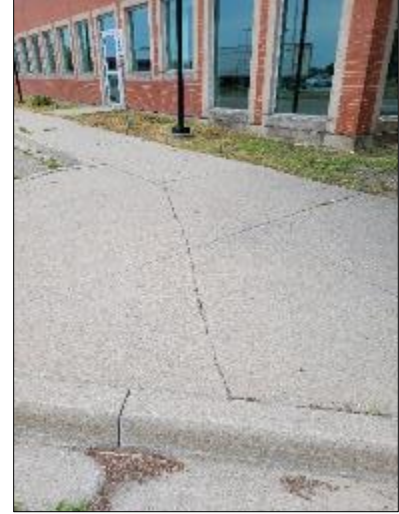
Photo C32:
Southeast Corner – Cracked sidewalk,
differential settlement.

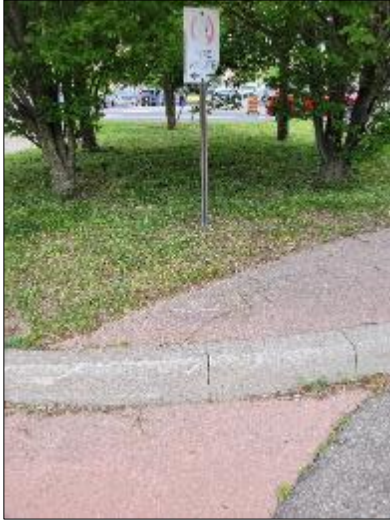
Photo C33

The curbs are generally in good condition, with some cracked and broken sections and some damage from likely winter maintenance activities. Three of the concrete bumper blocks on the south-east by the retaining wall are broken.

Opinion of Probable Cost for replacing sections of damaged curb is included in in Appendix G, Cost Feasibility Report.

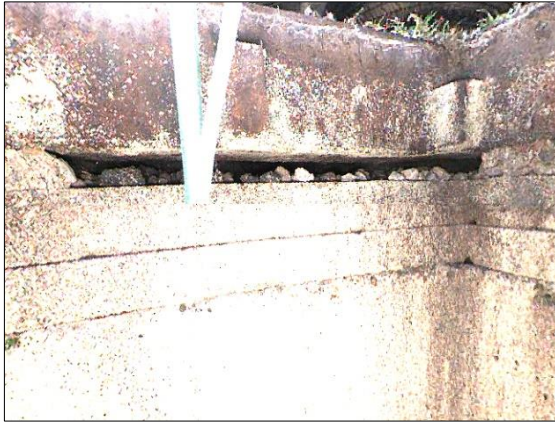
Photo C46:
CB 1: Frame mortar bed failure, typical of bed failures. Adjustment rings.

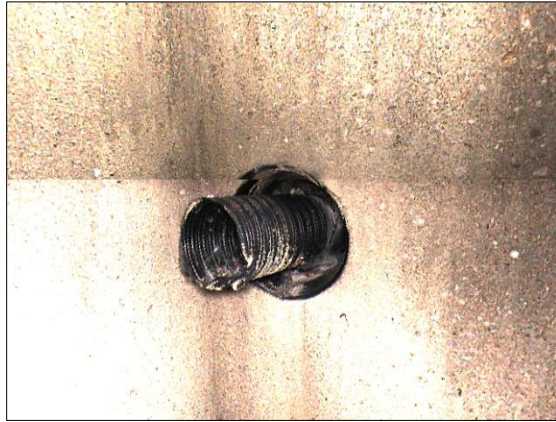
Photo C47:
CB 1: 100 mm HDPE weeper with joint seal.

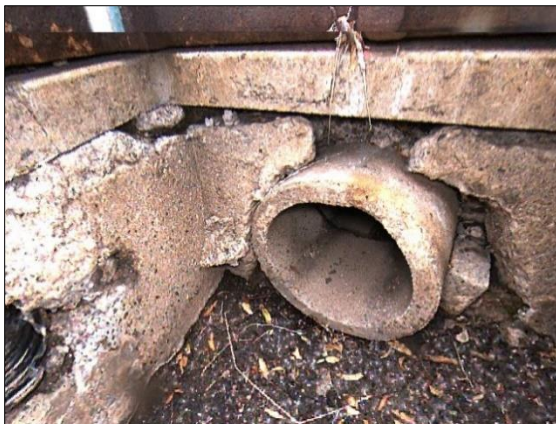
Photo C51:
CB 6: Structure Damaged

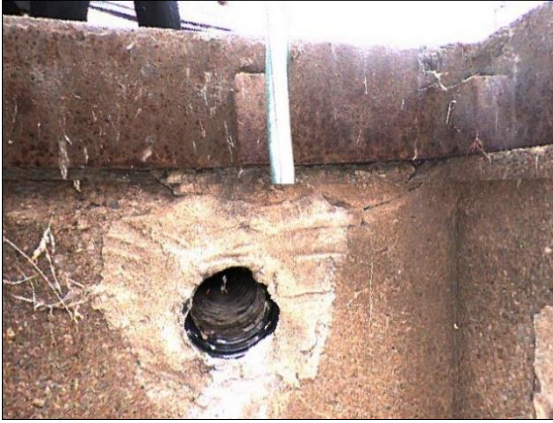
Photo C52:
CB 8: Damage to CB structure, mortar bed failure.

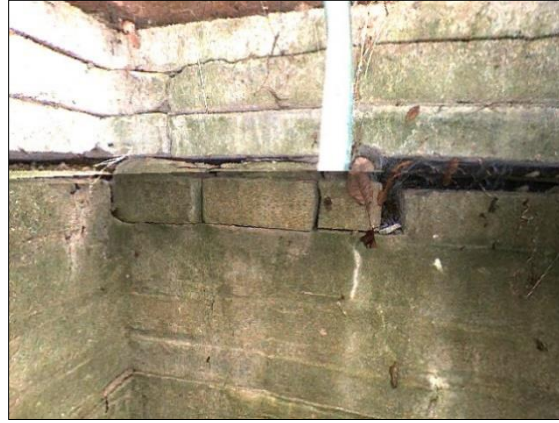
Photo C53:
CB 10: Cracked adjustment units/riser.

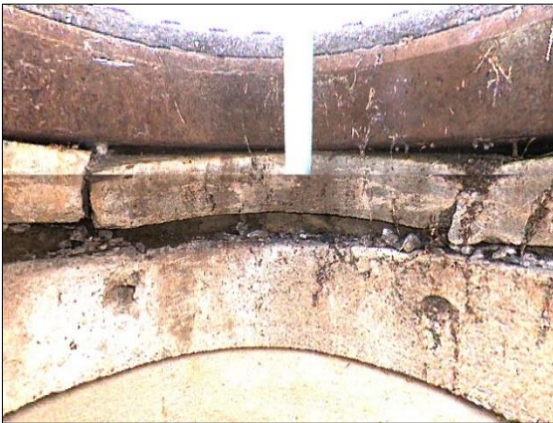
Photo C54:
STMH 1: Adjustment ring crack and mortar bed failure.

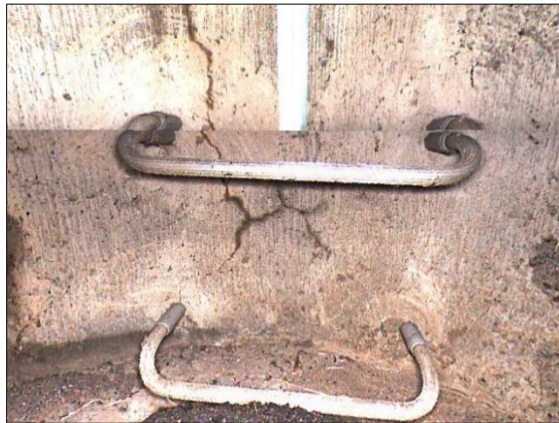
Photo C55:
STMH 1: Cracks in MH

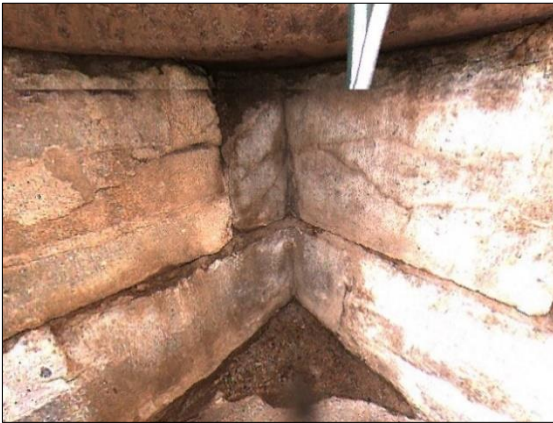
Photo C56:
STMH 2: Cracks Riser/Adjustment Ring

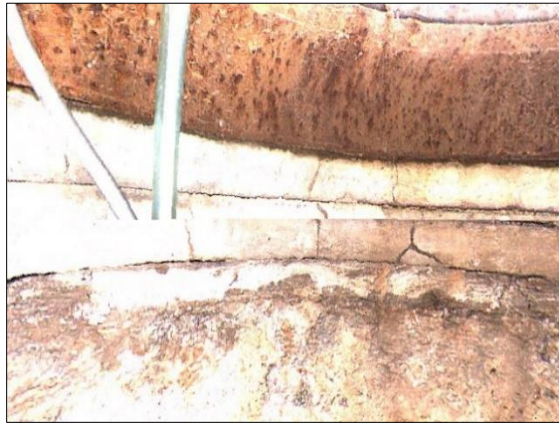
Photo C57:
STMH 3: Adjustment Ring Cracks

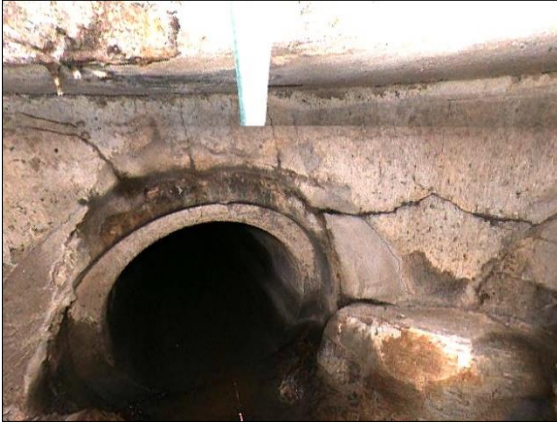
Photo C58:
STMH 3: Structure Cracks

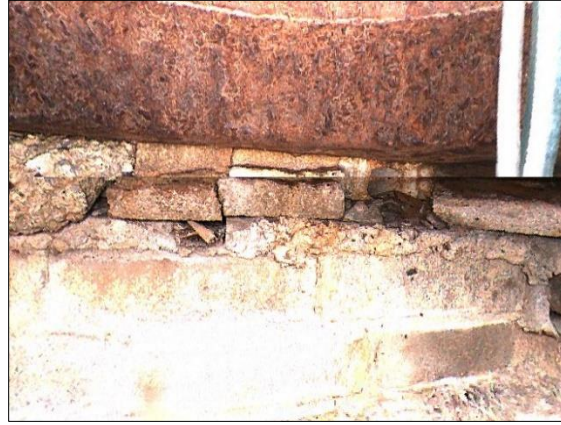
Photo C59:
STMH 5: Mortar bed/adjustment ring cracked.

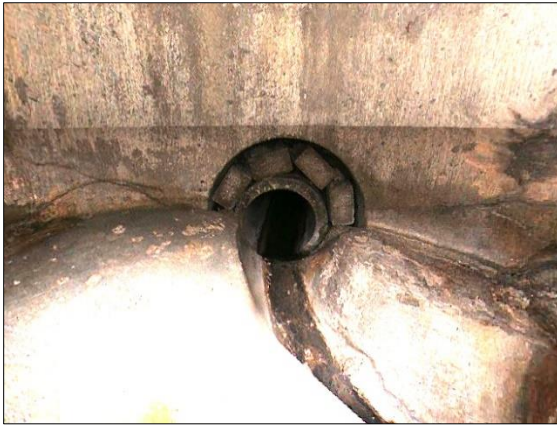
Photo C60:
STMH 5: Structure Cracks

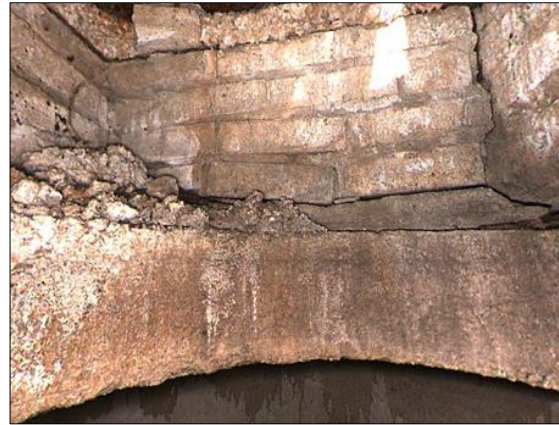
Photo C61:
SAN MH2: Cracked adjustment rings mortar bed.

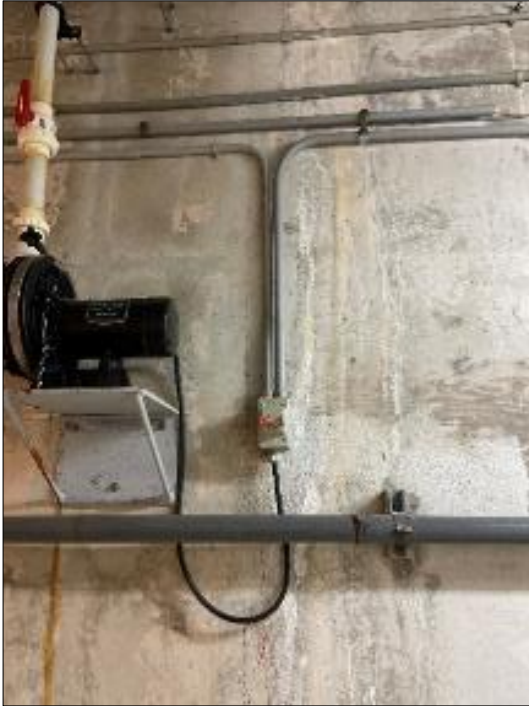
Photo ST 2:
Signs of leaking through pool wall.

There are many services running along these walls, such as electrical conduit, that the water would drip onto. The swimming pool should have a new waterproofing system installed, to contain any future problems, which would require retiling the surface of the pools walls and deck.

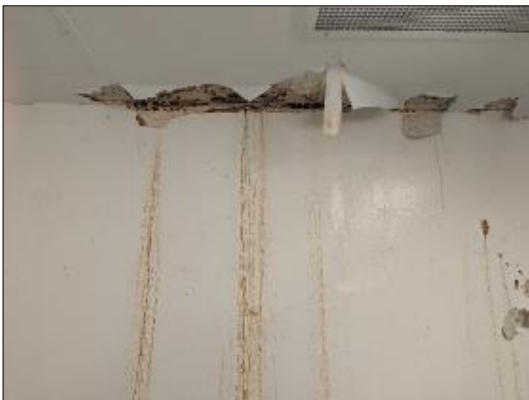
There were also signs of leaking within the laundry room, with water streaks and peeling paint with signs of water entry from above. The source of the leak is unknown and would require to be investigated further.

Photo ST 3:
Leaking in laundry room.

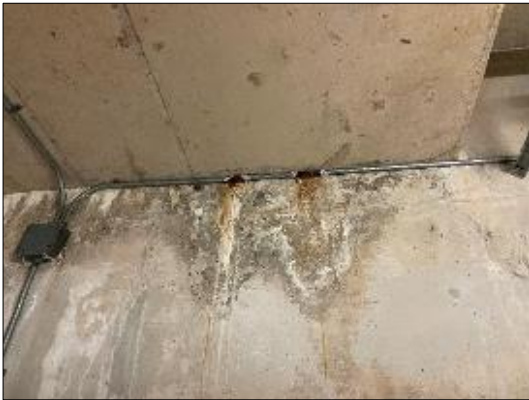
Photo ST 4:
Signs of leaking through Slab.

The repair suggestion for the pool walls would also be applied to the floor. The remainder of the floor shows no signs of structural distress and appears to be in good condition.

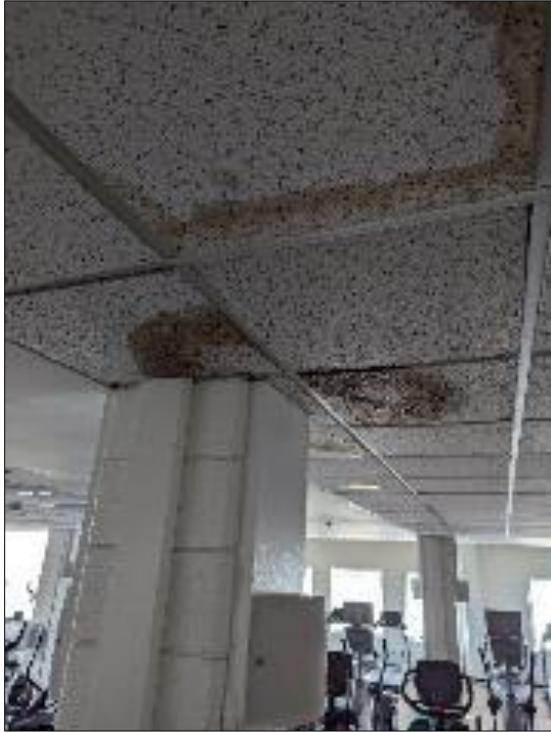
Photo ST 5:
Leaking through ceiling tile.

These areas should be investigated further to ensure that no structural concerns are found within.

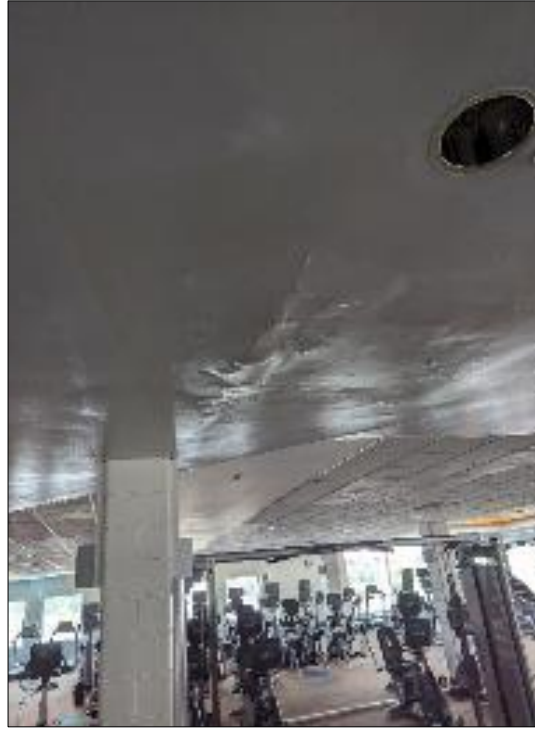
Photo ST 6:
Signs of ceiling water damage.

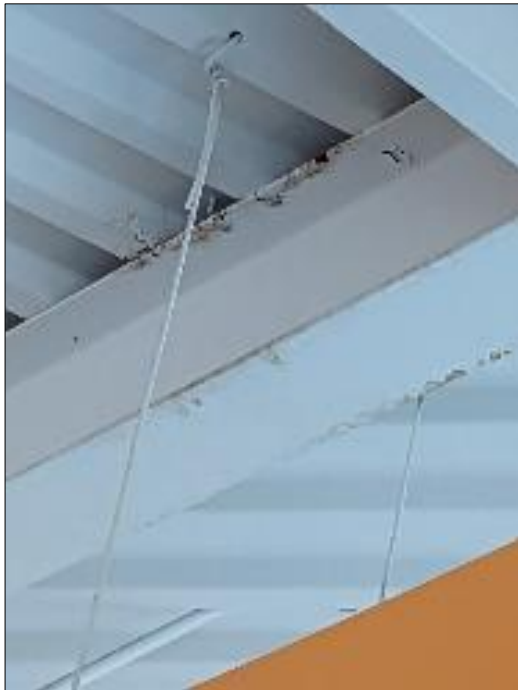
Photo ST 7:
Signs of water damage on structural framing.

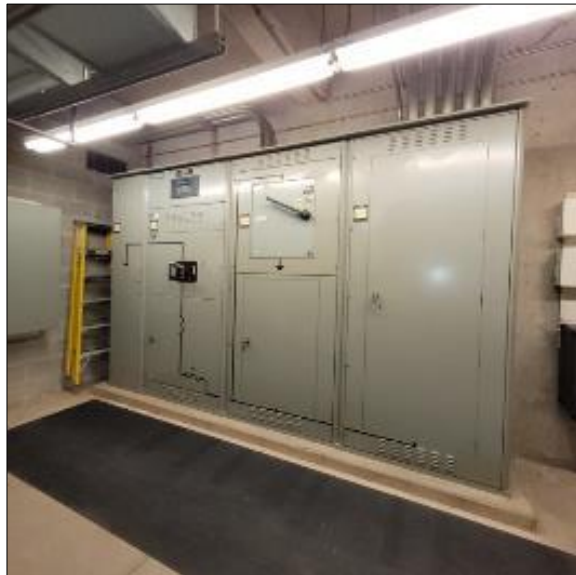
Typical life cycle of switchboard and service entrance equipment is around 40 years and it can be extended by proper maintenance. The equipment is in fair condition and will be approaching their end of life in 10 to 15 years.

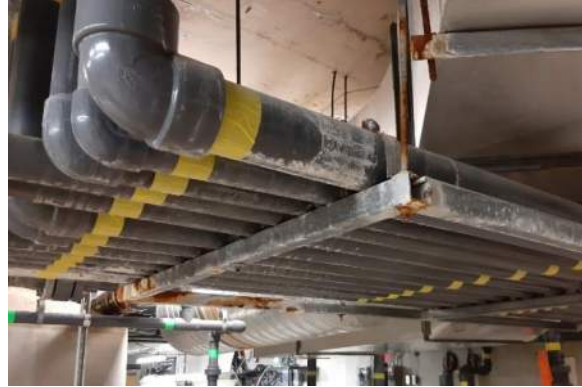
Figure 14 – Corroded Pipe Supports

Significant rust and corrosion on some old valves and pipe hangers was observed. It is recommended that these corroded valves, pipe hangers and supports be replaced.

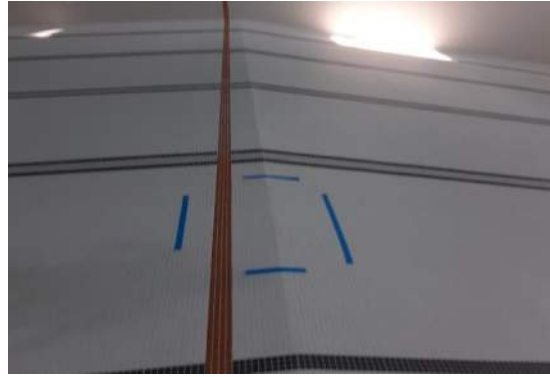
Figure 23 – Main Pool Tank, Marked Location of Tile Delamination

The Main Pool's tank interior is finished with 1" x 1" white mosaic tile throughout, and was found to be overall clean and in good condition on the surface. Racing lanes, end targets, and a diving board guide radius were observed to be present, tiled in a contrasting black, white, and grey pattern. There were no accent bands observed around the perimeter of the floor main drains, which is not in compliance with the requirements of OBC 2012. It is a requirement that a 2 inch wide (50mm) contrasting band will need to be installed around the main drains. It was observed that a 6 inch (150mm) black disc is present at the bottom of the deep end, which is in compliance with code. A chain drag test performed on the Main Pool tank tile has revealed that there were only one areas where the tiles were found to have been delaminated from the substrate, at the slope break point transition from the deep to shallow end. It is recommended that the tile in this area be removed and replaced.

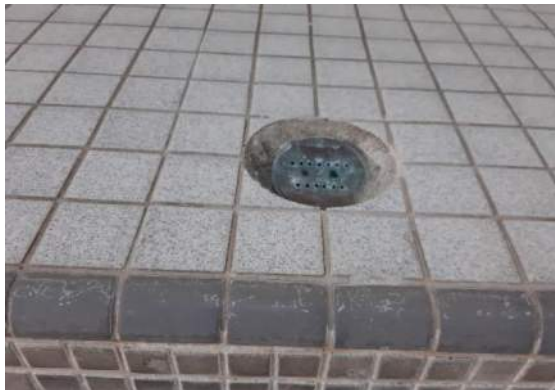
Figure 34 – Main Pool Spray Feature at Deck

The Main Pool was found to have two (2) spray water features installed on opposite sides of the pool deck. The water feature fittings are constructed of bronze has visibly corroded. It is recommended all gutter grilles be ground polished, and refinished with a protective coating for restoration
