CITY OF ST. CATHARINES

ST. CATHARINES YMCA BUILDING CONDITION ASSESSMENT & STUDIES

JULY 24, 2024

PROJECT NO.: CA0036719.6657
DATE: JULY 30, 2024

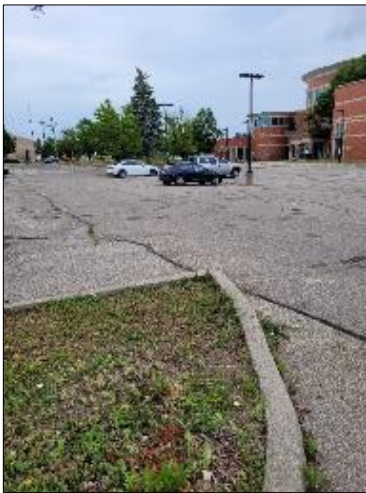
The visual inspection identified extensive cracking, alligatoring, asphalt erosion, oxidation and, in small areas, the loss of the surface asphalt indicating the pavement is at or near the end of useful life. Some of the cracks have been sealed and areas of pavement replaced – predominately in the vicinity of catch basins. The lack of rutting suggests that parking lot has sufficient base strength – i.e. granular, to support what will likely be mostly light vehicular traffic. The base structure is under drained with 100 mm HDPE piping discharging to the catch basins.

The alligator and longitudinal cracking is more predominant in low areas (i.e. areas where parking lot is graded to the center for drainage, for example on the north and south sides of building), which suggests the seam between two areas where asphalt put down let water in and that the alligator cracking resulted from water infiltration and not a result of base failure. It is noted that the storm sewer mains are not installed under these low points, so failure at the low areas is not a result of trench conditions.

Photo C1:
East parking lot closest to building looking south from north end. Longitudinal cracks, some sealed and grass growing in others. CB3 just east of light standard.

Replacement of parking lot asphalt by milling and placement of 55 mm Medium Duty Binder Course asphalt with maximum 20% RAP and 50 mm of HL 3HS asphalt. Opinion of probable cost for repaving the parking lot is included in Appendix G, Cost Feasibility Report.

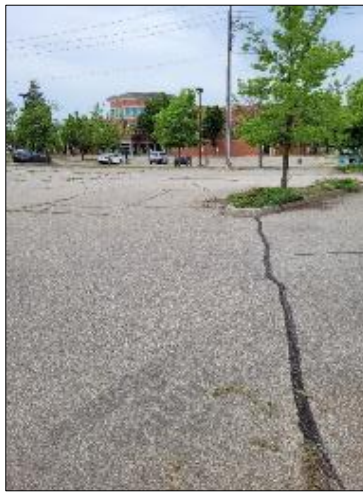
Photo C2:
East parking lot looking from northeast corner of property southwesterly. Cracking, grass growing in cracks. Oxidized asphalt. CB1 in mid picture.

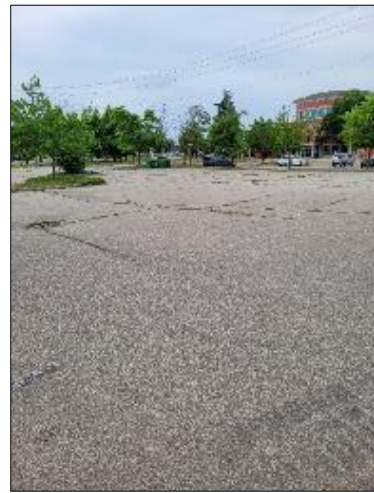
Photo C3:
East parking lot looking from northeast corner of property southwesterly. Cracking, grass growing in cracks. Oxidized asphalt. CB1 mid picture, at left.

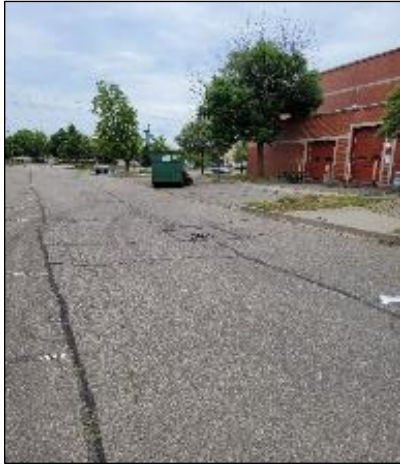
Photo C4:
North Parking lot looking east near north entrance. Alligator cracking along longitudinal cracks, longitudinal cracking 5.5 m off curb, patching CB 5.

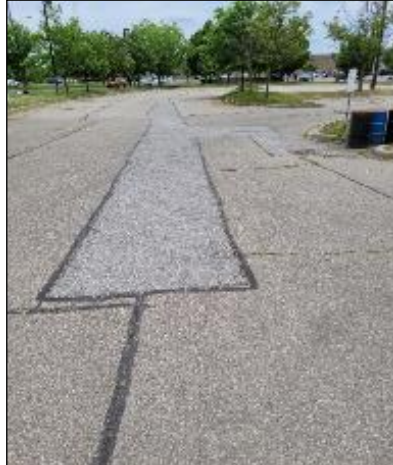
Photo C5:
North Parking Lot looking east from northeast entrance. CB 4 in background, patching down center of lot and around CB, longitudinal cracks, some sealed. Grass in others.

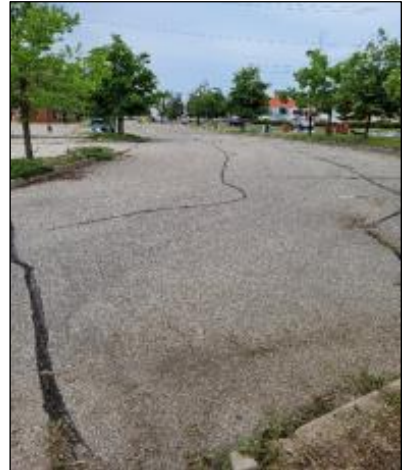
Photo C6:
North Parking Lot looking west from northeast corner of the lot. Cracking, some previously sealed, grass growing in some.

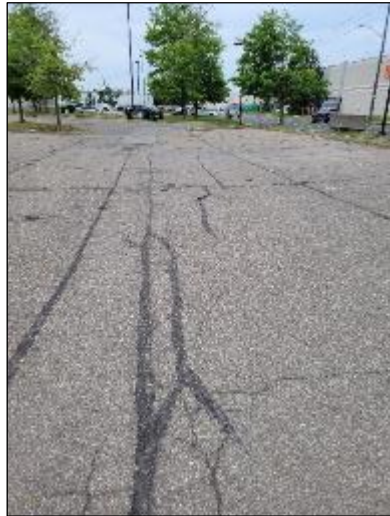
Photo C7:
North Parking looking west from area of transformer. STMH 4 and CB6 in background. Longitudinal cracking, some previously sealed and sealing failing.

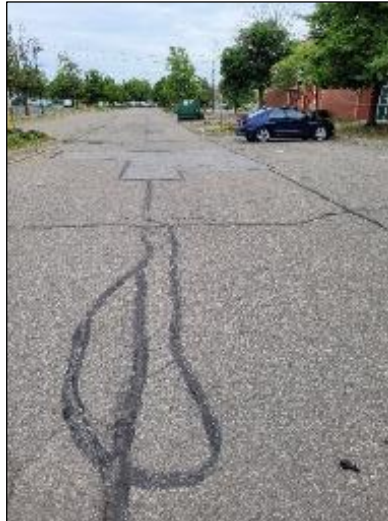
Photo C8:
North Parking looking east from area of transformer. STMH 3 and CB5 in background. Longitudinal cracking, some previously sealed and sealing failing, patching at MH and CB.

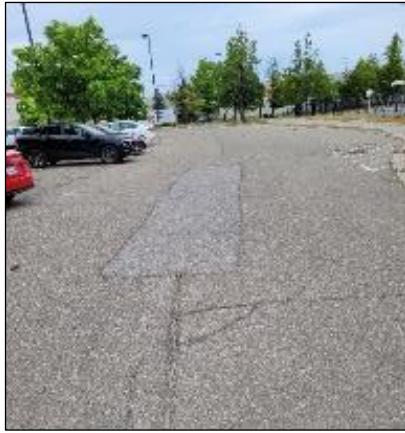
Photo C10:
West Parking – Looking north from south end, cracking, previously sealed, patching, asphalt erosion. CB7 top right.

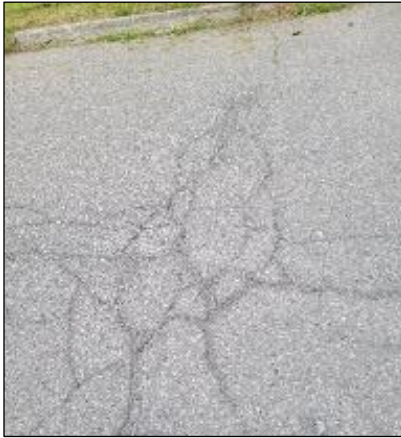
Photo C11:
West Parking – Longitudinal and alligator cracks, loss of asphalt.

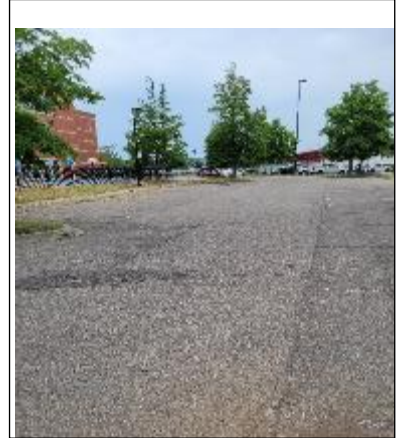
Photo C12:
West Parking – North end, looking south, alligator and longitudinal cracks with grass growing.

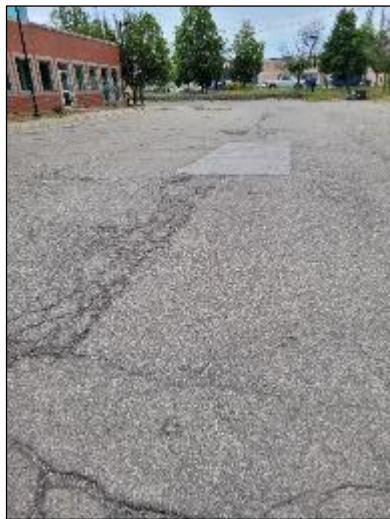
Photo C13:
South Parking Lot Looking East to CB8 – Extensive cracking, patching, asphalt erosion, asphalt loss.

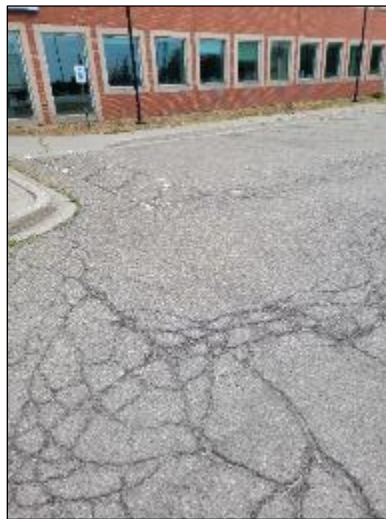
Photo C14:
South Entrance – Alligator cracking, loss of asphalt.

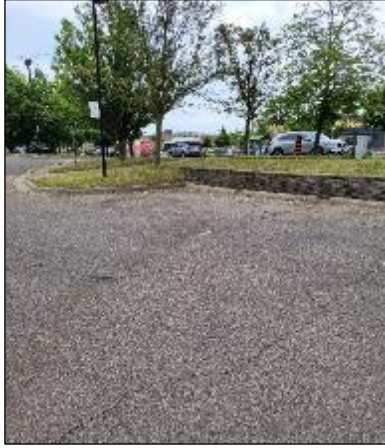
Photo C16:
Southeast parking lot looking northeasterly. Longitudinal cracking, eroding asphalt, retaining wall in background.

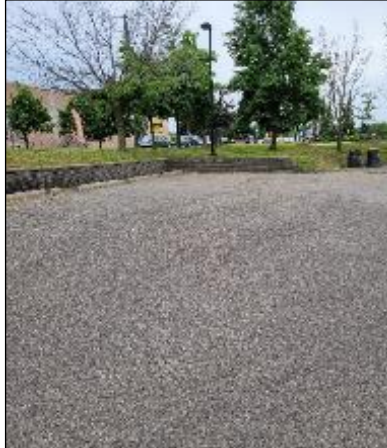
Photo C17:
Southeast parking lot looking southerly. Longitudinal cracking, alligator cracking, eroding asphalt, retaining wall in background.

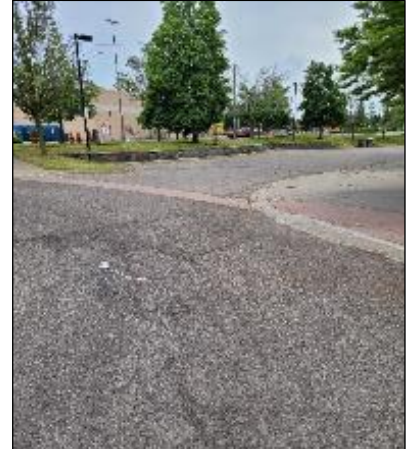
Photo C18:
East Entrance – Extensive cracking & asphalt erosion.

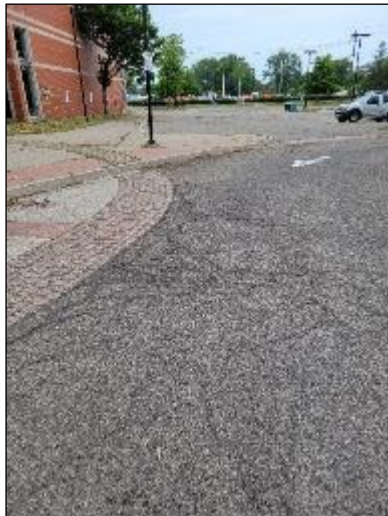
Photo C19:
East Entrance – Extensive cracking & asphalt erosion

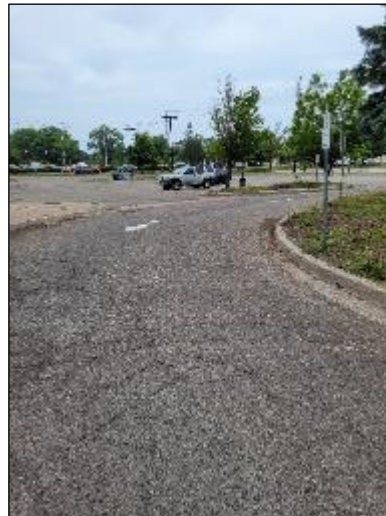
Photo C20:
East Entrance – Extensive cracking & asphalt erosion, loss of asphalt

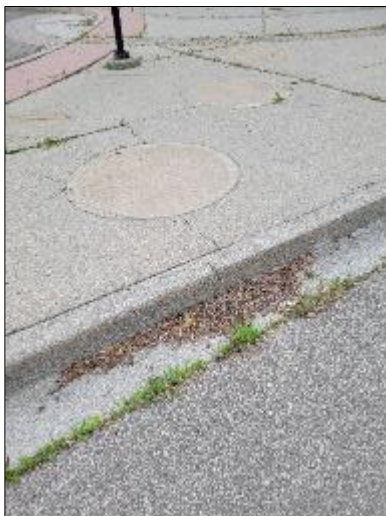
Photo C21:
East Entrance – Sidewalk cracked,
differential settlement sidewalk, curb.

- Level settled sidewalks.
- Level interlocking block that has settled relative to adjacent concrete.
- Rout and grouted or the cracked sections sidewalk or removed and replace.
- Remove and replaced cracked and heaved sidewalk at northeast corner of building.

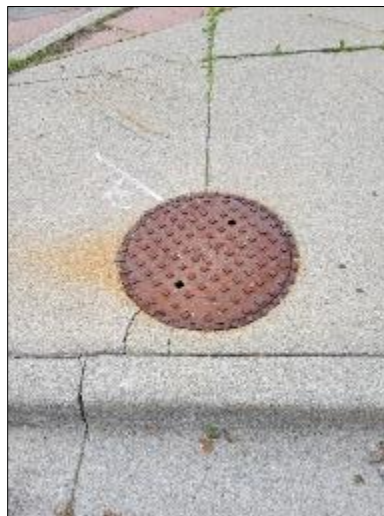
Photo C22:
East Entrance – Sidewalk crack at SAN
MH2. MH2 requires replacement of
adjustment rings.

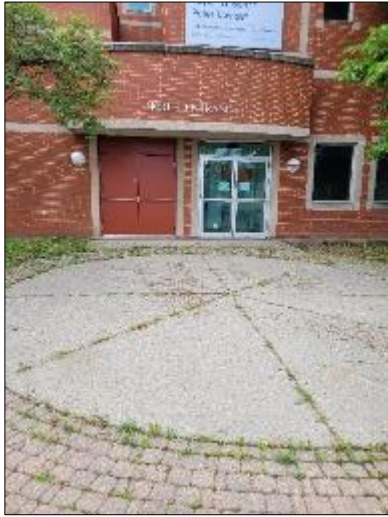
Interlocking block at the east and north entrances settled relative to the concrete sidewalk and represents a trip hazard.

Photo C24:
North Entrance –Sidewalk and interlocking block settled relative to each other.

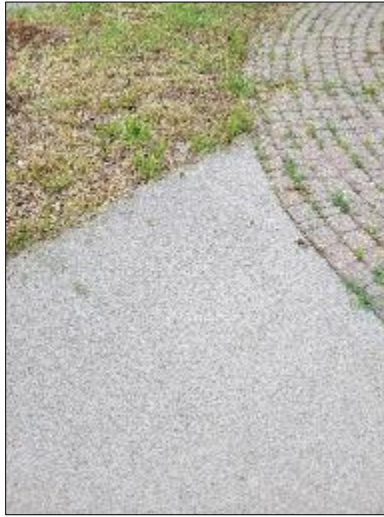
Bolts stick up out of the sidewalk at the North entrance and out of the concrete slab beside the gas meter and should be cut flush with the sidewalk/slab to remove trip hazards.

Photo C25:
North Entrance – Bolts sticking up in sidewalk.

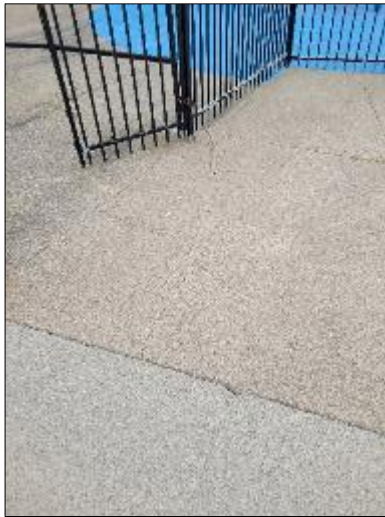
Photo C27:
West at Splash Pad Entrance
cracked sidewalk.

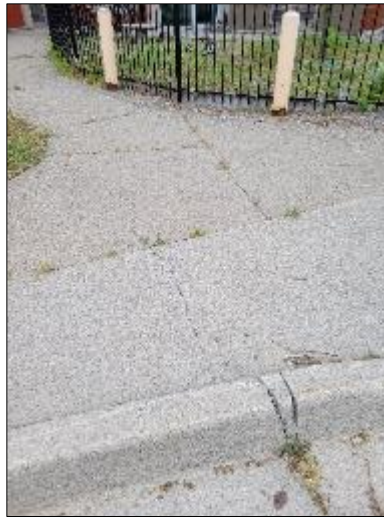
Photo C28:
West Entrance – Cracked sidewalk
and broken curb. Sidewalk settled
relative to curb.

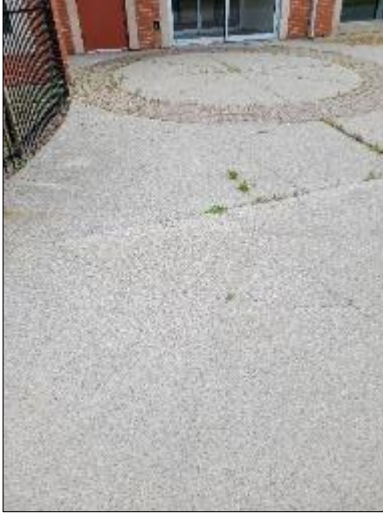
Photo C30:
South Entrance – Cracked sidewalk,
differential settlement.

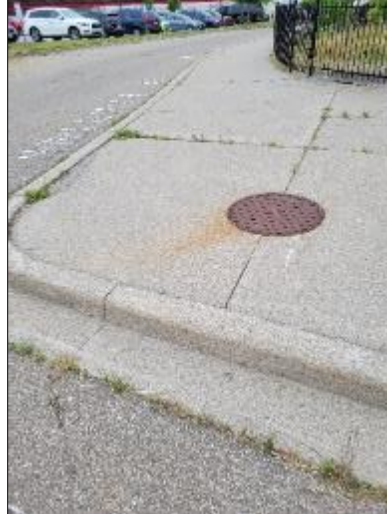
Photo C31:
South Entrance – Cracked sidewalk.
STMH 5 requires replacement of
adjustment rings, differential settlement.

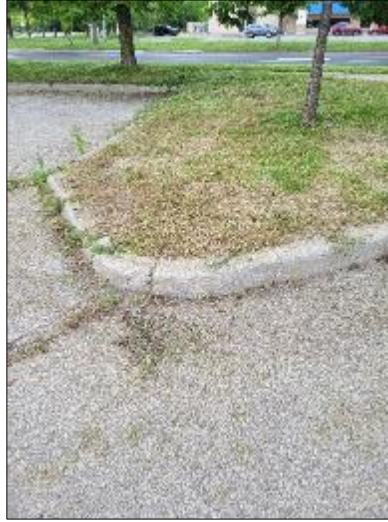
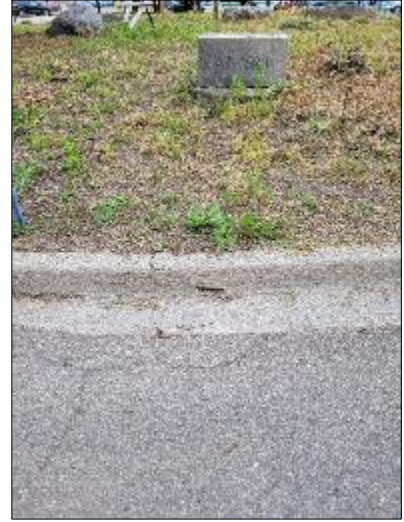
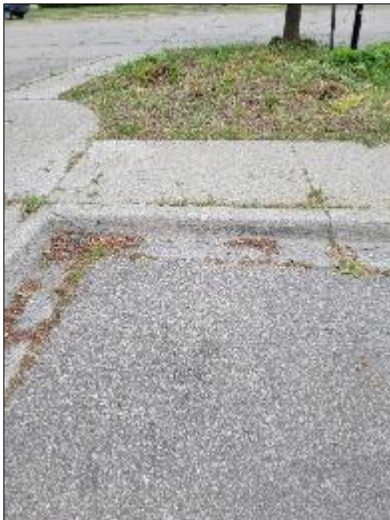
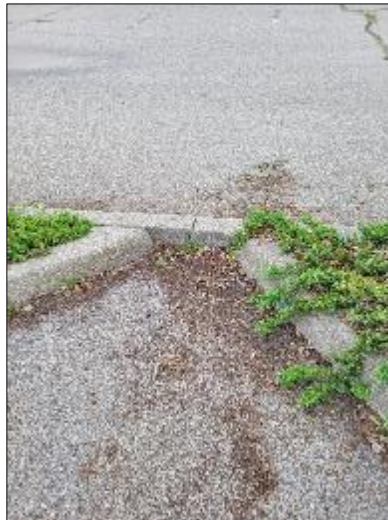
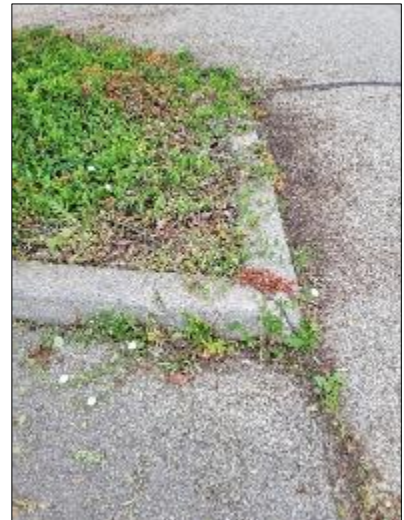
The curbs are generally in good condition, with some cracked and broken sections and some damage from likely winter maintenance activities. Three of the concrete bumper blocks on the south-east by the retaining wall are broken.

Opinion of Probable Cost for replacing sections of damaged curb is included in in Appendix G, Cost Feasibility Report.

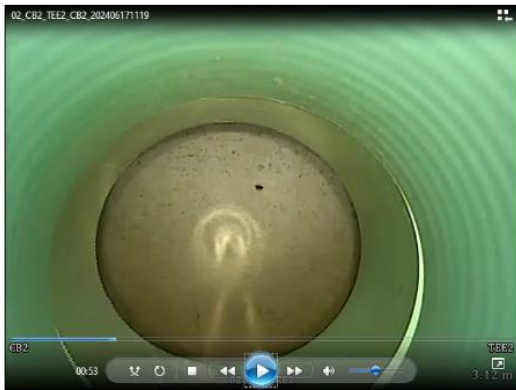
Photo C39:
CB 2 Lead: Connection to storm trunk sewer.

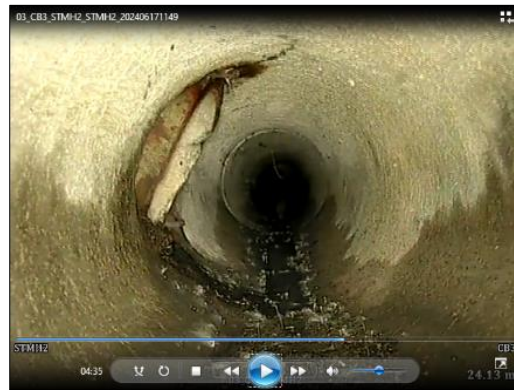
Photo C40:
Lead CB 3 to STMH 2: Connection from CB 4.

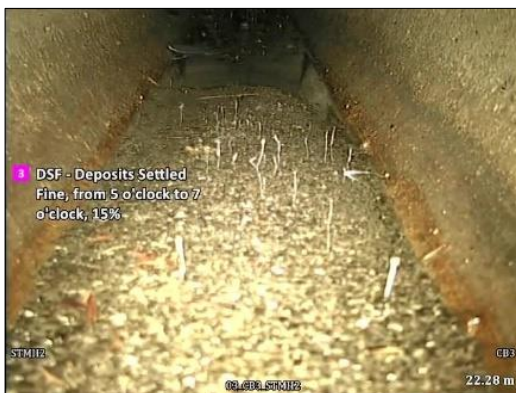
Photo C40:
Lead CB 3 to STMH 2: Deposits in pipe.

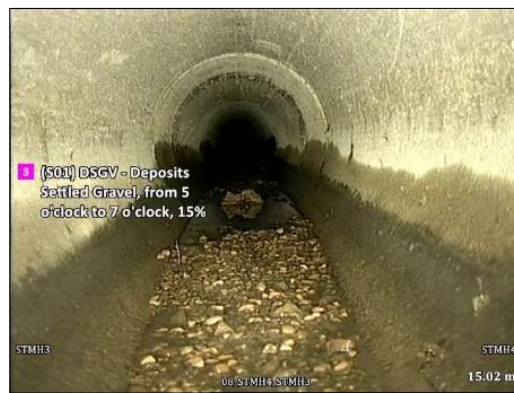
Photo C41:
STMH 3 – STMH 4: Deposits in pipe.

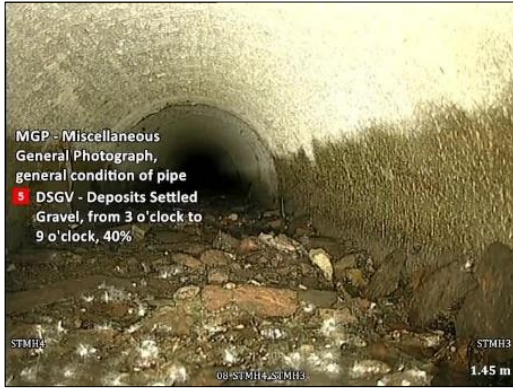
Photo C42:
STMH 4 – STMH 3: Deposits in pipe.

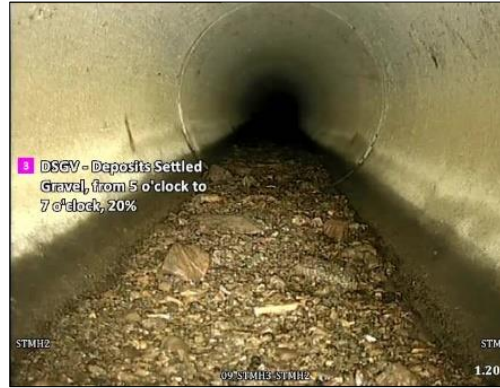
Photo C43:
STMH 2 – STMH 3: Deposits in pipe, survey abandoned 1.88 m due to deposits.

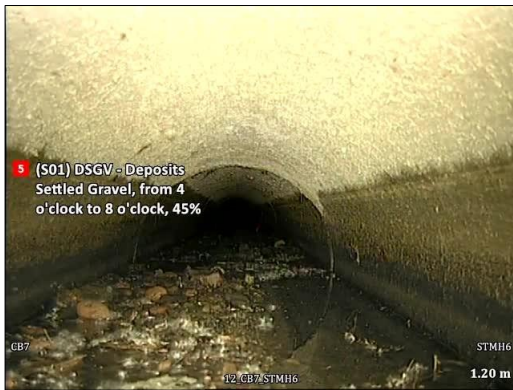
Photo C44:
CB 7 to Buried STMH 6: Debris in pipe

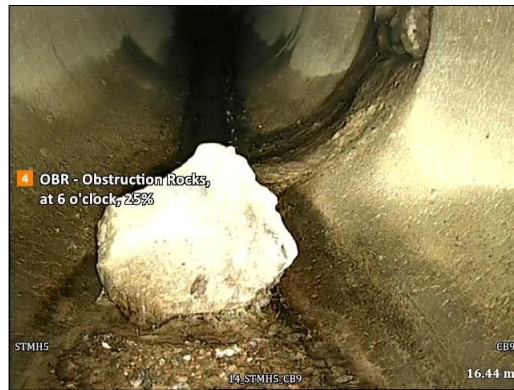
Photo C45:
STMH 5 – CB 9: Debris in pipe, lead from CB 8 top right.

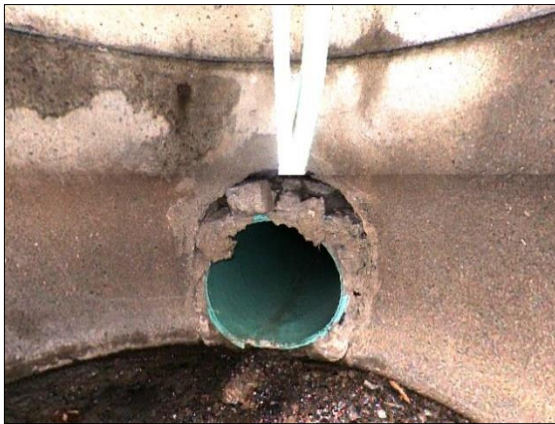
Photo C48:
CB 2: Joint Seal

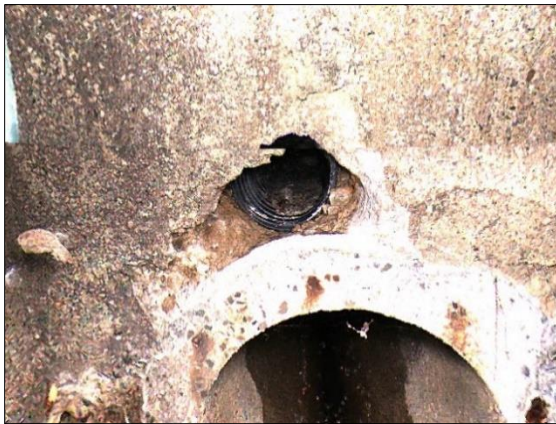
Photo C49:
CB 3: Weeper connection above storm pipe.

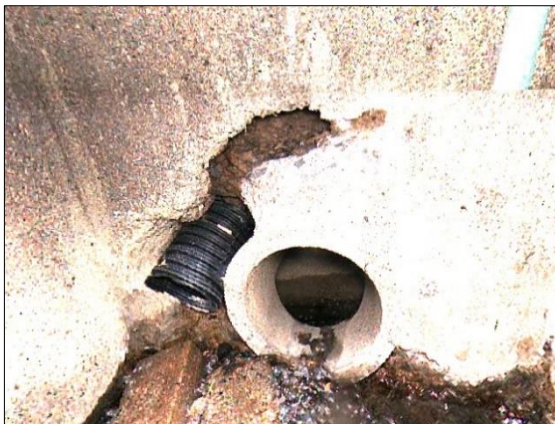
Photo C50:
CB 4: Weeper Connection

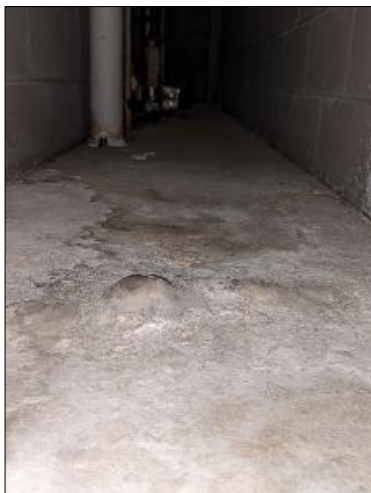
Figure 9: Photo of Slab on Grade Change Room

The visible portions of the slab on grade mostly looked in good shape with small cracks which are expected for the age of the building. Within the maintenance walls of the ladies changerooms, there was some heaving with unknown origin, which can be a tripping hazard for people working within that confined space.

Photo ST 1:
Slab on Grade Heaving

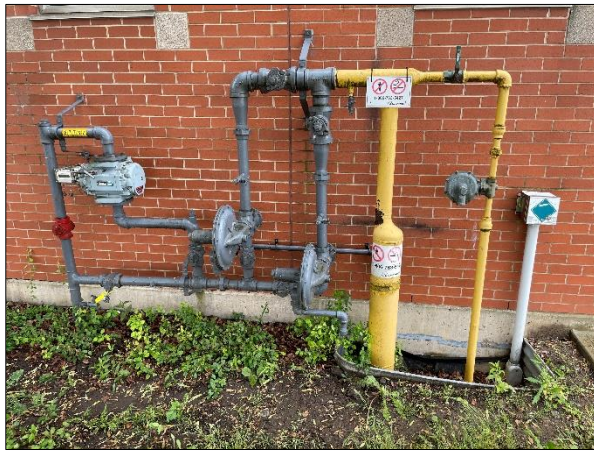
The natural gas piping located at the roof level of the building is painted so it can be easily identified, however; we observed some surface corrosion. We recommend cleaning and re-painting (with yellow rust resistant paint) the natural gas pipes located at roof level. This is considered to be part of regular building maintenance and has not be included in the cost report.

Photo M1:
2 PSI incoming gas service meter and regulator.

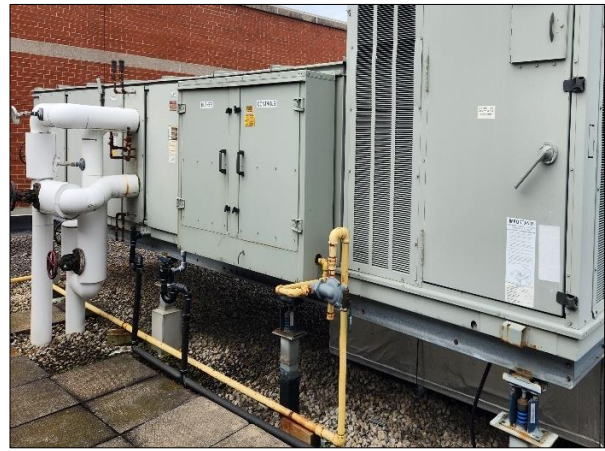
Photo M2:
Typical gas piping connection to equipment with regulator.

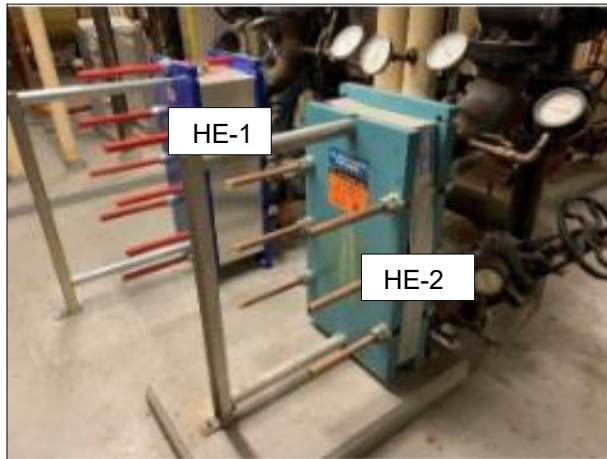
The hydronic heating loop currently is connected to the condenser loop to inject heat into the condenser loop through heat exchanger HE-2. HE-2 is original to the building and has reached end of life and requires replacement. As part of the replacement of boiler B-1, we recommend removal of HE-2 and associated pumps and piping to connect the new condensing boiler directly to the condenser loop.

Photo M4:
Heat Exchangers #1 and 2

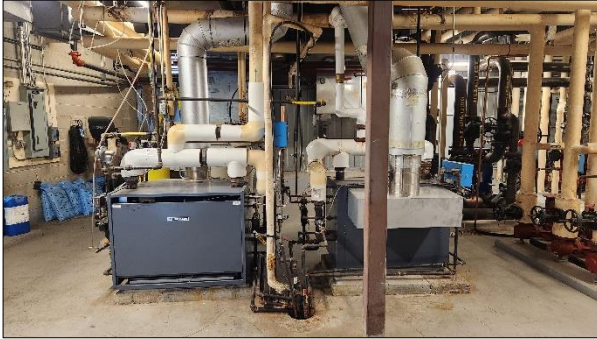
Steam humidification for the steam saunas is generated by two natural gas-fired steam boilers having a maximum input firing rate of 360,000 Btu/Hr. The steam boilers are manufactured by “Weil McLain”. According to the service tag on the boilers, they were both replaced in 2019 and have approximately 20 years of service life left in them. We will recommend including for initial servicing of the boilers prior to restarting. An allowance for this has been included in the cost report.

Photo M6:
Steam Boilers Serving Steam Rooms

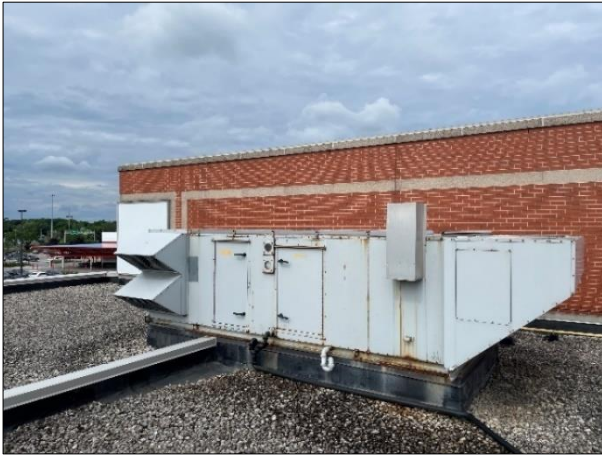
RT-7 is a mixed air unit serving the 2nd floor addition onto the fitness area and is equipped with economizer with barometric relief dampers, DX cooling and indirect gas fired burner. This unit is using R22 refrigerant which has been phased out and no longer being manufactured, making it difficult and costly to procure in the event of a refrigerant leak. This unit is original to the addition which was in the late 90's, making the unit approximately 25 years old and at end of its expected service life. We recommend replacement of RT-7 with a new unit like-for-like utilizing new low global warming potential (GWP) refrigerant. The cost for the like-for-like replacement of RT-7 is included in the cost report. For further recommendations for this unit, refer to the decarbonization section of this report.

Photo M19:
RTU-7 - Serving 2nd Floor Addition

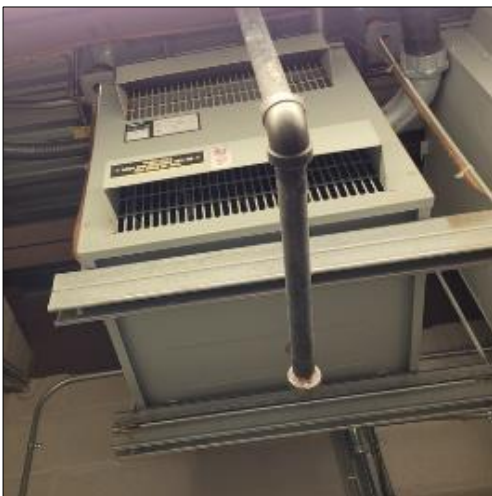
Photo E3:
Typical Ceiling Mounted Transformer in Elec Rooms

Typical life cycle of distribution equipment including panels, transformers, disconnect switches and splitters is around 30 years and it can be extended by proper maintenance. The equipment will be approaching their end of life in one to five years.

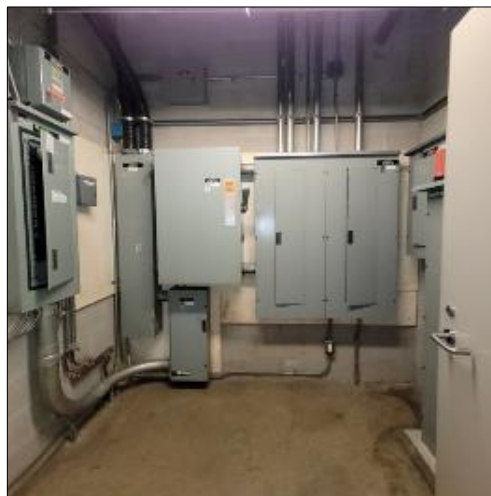
Photo E4:
Typical Distribution Equipment in Elec Rooms

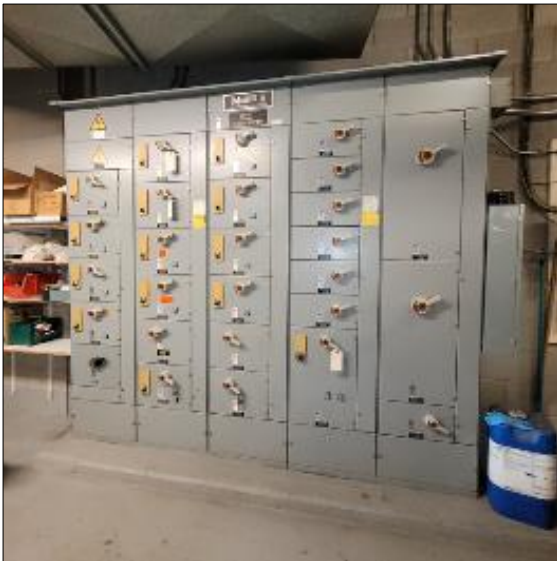
Photo E5:
MCC 1 in 3rd Floor Mechanical Room

Typical life cycle of MCCs is around 30 years and it can be extended by proper maintenance. The equipment will be approaching their end of life in one to five years.

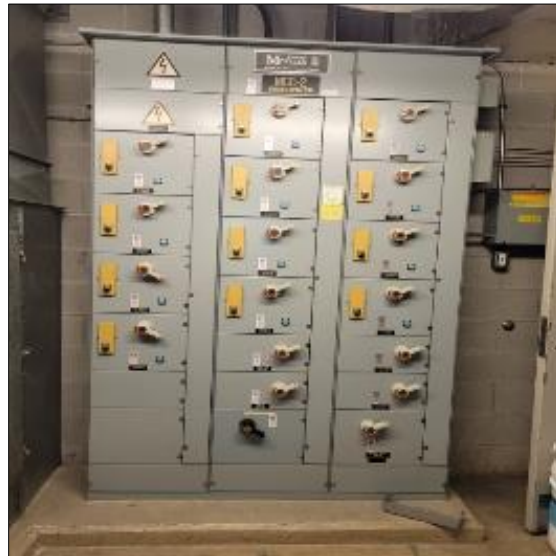
Photo E6:
MCC 2 in Basement

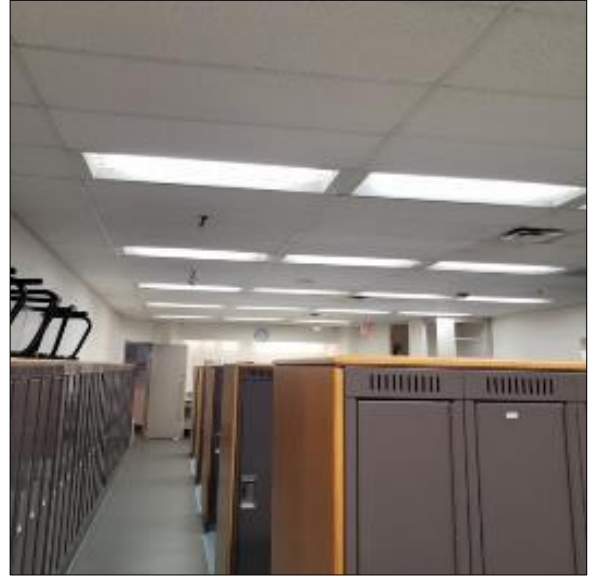
Photo E9:
Typical Lighting Fixtures in Gym and Change Rooms

Typical life cycle of lighting fixtures is around 20 years. The equipment passed their end of life.

It is recommended to have all base building fixtures/tubes be retrofitted with new LED retrofit kits or replaced with new LED fixtures to reduce the energy consumption.

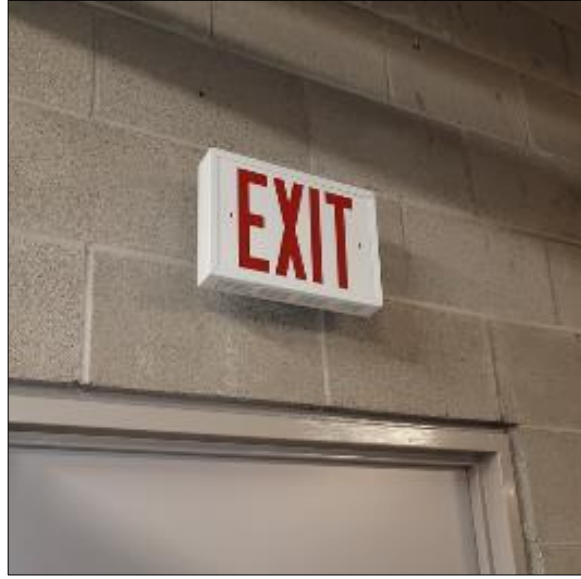
Photo E13:
Typical Remote Heads and Battery Units

It is recommended to have the entire emergency lighting battery units and remote heads to be replaced with new equipment.

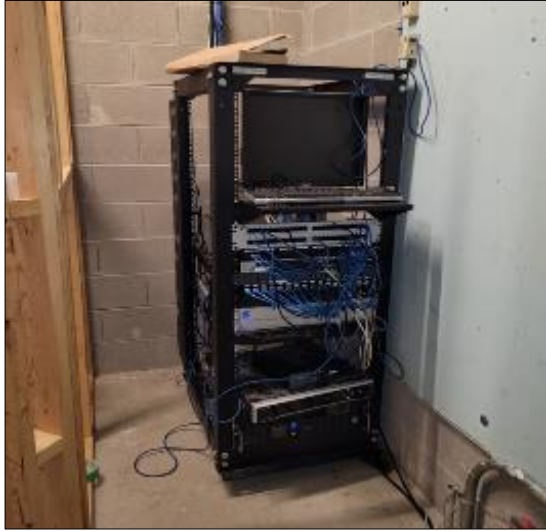
Main IT rack and server are located in the elevator machine room in basement and seems to be in good condition. There is another IT rack in an electrical room. The data/voice drops seem to be old.

Photo E15:
Main IT Rack in Elevator Machine Room

Replacement to be done within next five years according to the building operation requirements.

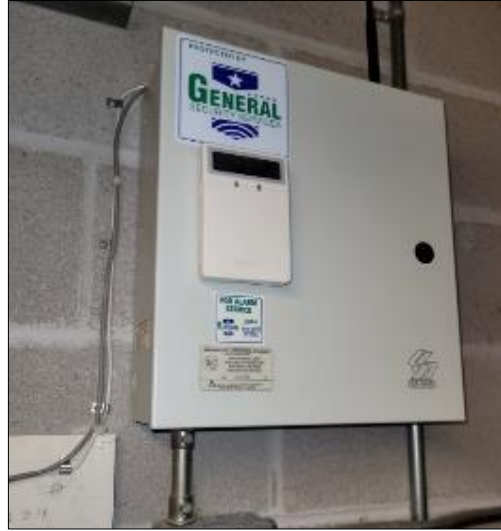
Main security panel is located in main electrical room in basement and seems to be in fair condition. The intrusion alarm system is monitored by General Security Services. There are some cameras around the building as well which seems to be in fair condition.

Photo E16:
Main Security Panel

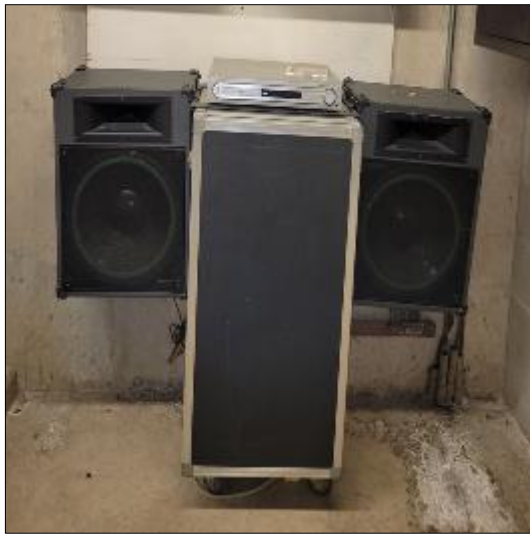
The PA system is located in main electrical room in basement and seems to not be in fair condition and is not working.

Photo E17:
Obsolete PA System

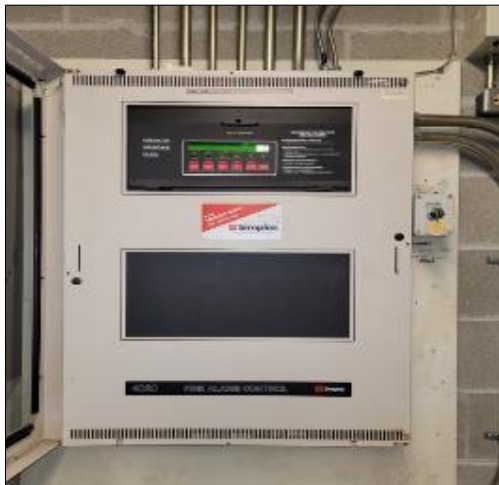
Photo E19:
Main Fire Alarm Control Panel

The fire alarm control panel has an expected useful service life of 20 years and the fire alarm devices has 10 years useful service life. Most of the devices passed their useful life cycle.

It is recommended to verify the capacity of the existing fire alarm panel to determine if new strobes can be added. This can be investigated with the fire alarm panel manufacturer and the fire alarm contractor on site.

It is recommended to have the entire fire alarm system replaced with new equipment.

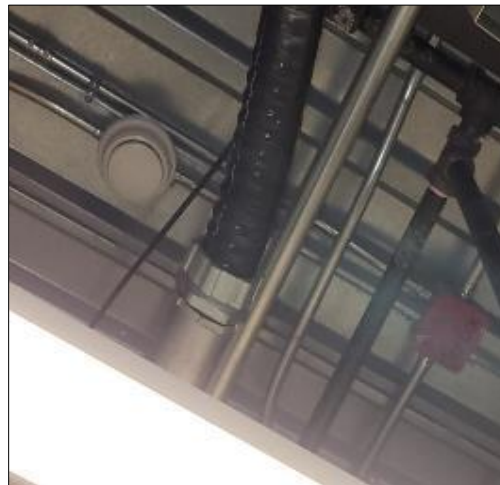
It was observed that smoke detectors are installed within the electrical rooms throughout the building.

Photo E20:
Typical Fire Alarm Detector in Elec Rooms

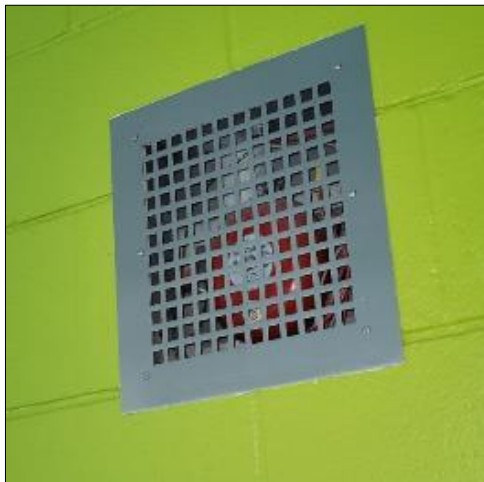
Photo E21:
Typical Fire Alarm Bell in Common Area

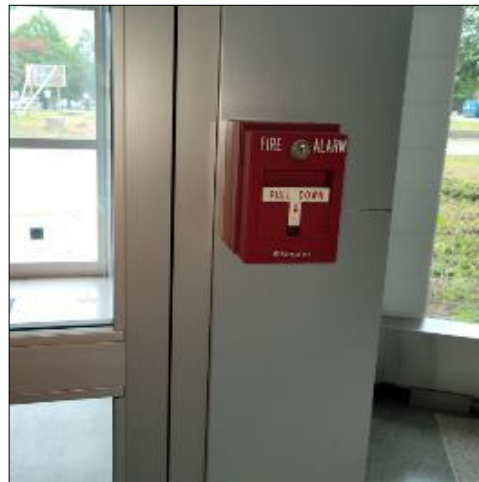
It appears that the mounting heights of the fire alarm pull stations at exit doors throughout the building may not all meet the current AODA requirements.

Photo E22:
Typical Fire Alarm Pull Station at Exit Door

It is recommended to investigate the mounting heights of the existing fire alarm pull stations to determine whether they satisfy AODA's latest requirements.

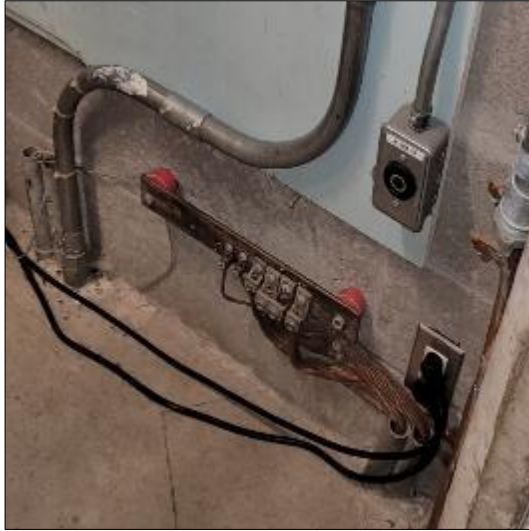
It appears that there are copper bonding conductors in the electrical rooms which are bonded to the building ground through grounding bars. The grounding system is original to the building and was observed to be in good condition throughout all electrical rooms.

Photo E23:
Grounding Busbar in Elevator Machine Room

Typical life cycle of grounding system is around 40 years. The equipment will be approaching their end of life in 10 to 15 years.

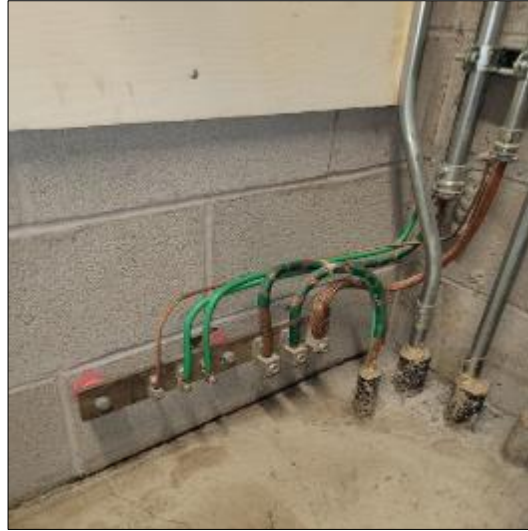
Photo E24:
Typical Grounding in Elec Rooms

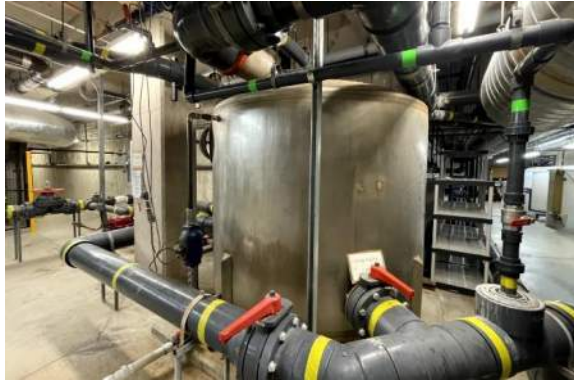
The Main Pool system contains one (1) vertical balance tank located in the pool mechanical room. The main drains and gutters from the Main Pool work on a gravity system connected to the balance tank, from which the filter pump pulls water. As the balance tank did not have a visible nameplate, the manufacturer and capacity could not be verified. The balance tank and associated Schedule 80 PVC pool water piping appeared to be in fair condition

Figure 1 – Main Pool Balance Tank

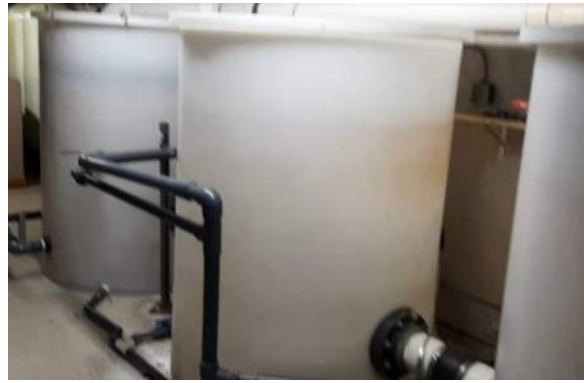
The Splash Pad system contains three (3) vertical interconnected balance tanks, from which the Splash Pad filter and feature pumps draw water from. A water level sensor complete with clear sight glass was observed. While the Splash Pad balance tanks appeared to be in fair condition, they require a thorough cleaning, as a significant amount of black grime was found settled at the bottom of the tanks, appearing to have not been cleaned since the facility's closure.

Figure 2 – Splash Pad Balance Tanks

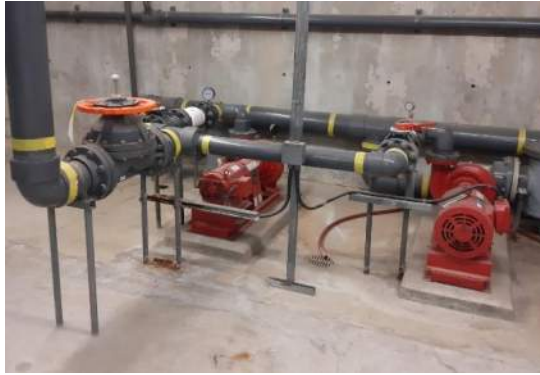
Figure 3 – Main Pool Filter Pumps

No variable frequency drives (VFD) were noted on the circulation pumps for any of the pools. VFDs are motor control devices which control the speed of circulation pumps. They are devices connected and controlled by the flow meter within the filtration system. The flow meter is programmed to a set flow and the VFD controls the pump; increasing or decreasing the pump speed to maintain a set flow rate. It is recommended that VFDs be incorporated into the filtration systems. The addition of this system would result in an improvement in energy efficiencies by controlling the pump speed and reducing energy consumption.

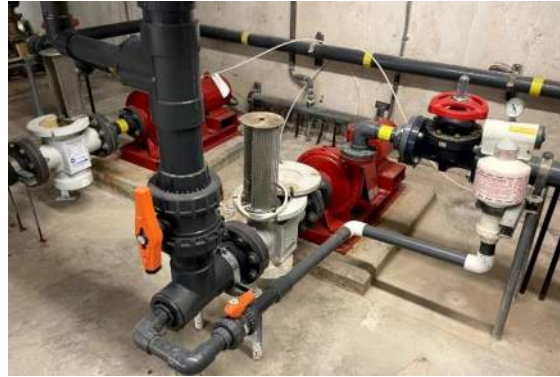
The Whirlpools each have one (1) filter circulation pump, both of which are manufactured by Armstrong and are 5 HP, 575V, 3-phase. The pumps are both designed to operate at 140 US GPM at 70 ft of total dynamic head. The Whirlpools each also have one (1) hydrotherapy jet pump, both of which are manufactured by WEG and are 7.5 HP, 575V, 3-phase. All of these pumps appear to be in fair condition from a visual inspection, though were not operational during time of site visit.

Figure 4 – Whirlpools’ Filter Pumps

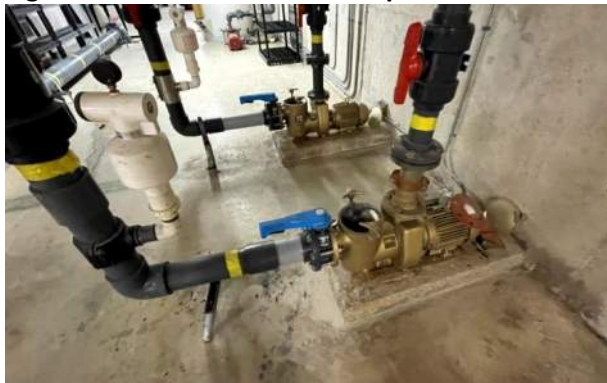
Figure 5 – Whirlpools’ Hydrojet Pumps

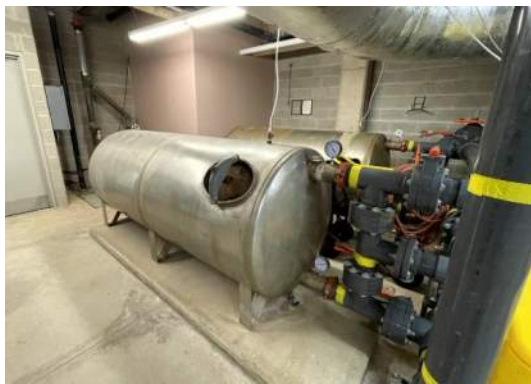
Figure 7 – Main Pool Horizontal Sand Filters

If the Main Pool filtration system were to be upgraded to accommodate a turnover rate that complies with OBC 2012 Section 3.11.8.1.5.(a), an increased flowrate of 1000 US GPM would be recommended. This would meet and exceed OBC 2012 requirements, and providing a buffer for when the pool is in active use and the filters are under heavy load. The existing filtration system does not have the capacity to service this increase, and a new filter system would be required.

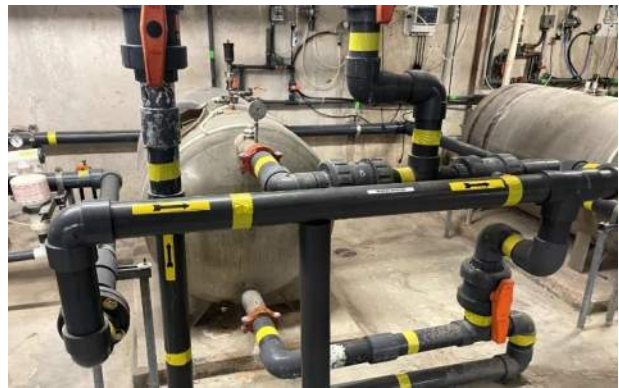
The Men and Womens' Whirlpool filtration systems each consist of one (1) horizontal sand filter (SFD-61), manufactured by Kenloch, from the original construction of the facility. The bodies of the filter tanks are constructed of stainless steel, and appear to be in fair condition for their age, with a moderate amount of corrosion observed on the surface. Each respective filter has a filter area of 14 sq. ft. Each of the Whirlpool filter pumps are 5 HP, and operate at 140 US GPM to each of their respective filters. For both Whirlpools, this data would translate into a filtration rate of 10.0 gallons per sq. ft. which is an ideal filtration rate for this type of filter. As with the Main Pool filtration system, if this filtration system is to remain, it is recommended that all new filter media be installed, and the filter internals be assessed to confirm that they are still in acceptable working condition. Water level controllers for each of the two Whirlpools were observed to be installed, automatically sensing the water level in the pools and signalling when replenishment is required.

Figure 8 – Whirlpools' Horizontal Sand Filters

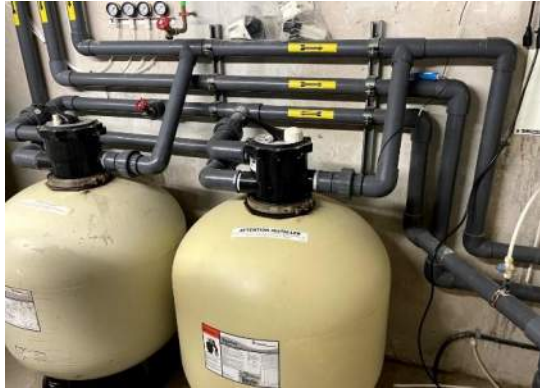
The Splash Pad filtration system consists of two (2) top mount sand filters (TA-100HD), manufactured by Pentair. The bodies of the filter tanks appeared to be in good condition. Each respective filter has a filter area of 4.9 sq. ft., for a combined total filter area of 9.8 sq. ft. Downstream of the sand filters are two (2) water softener tanks that appeared to be in good condition. The existing Splash Pad filter pump is 1 HP, although its operating flowrate could not be determined. The water in the interconnected balance tanks are drawn by a dedicated filter pump, and goes through the sand filters, water softener tanks, and UV system before feeding back into the same interconnected balance tank system. A feature pump on the other side of the balance tank system then draws water and sends them to the splash pad water features, which means the filtered and UV-sanitized water in the balance tanks appear to be mixed together with the water from the splash pad drains that return directly to the same balance tank system. This system does not comply with current Health Regulations related to Splash Pads and Recreational Water Illness and must be reworked before the Splash Pad is reopened.

Figure 9 – Splash Pad Vertical Sand Filters

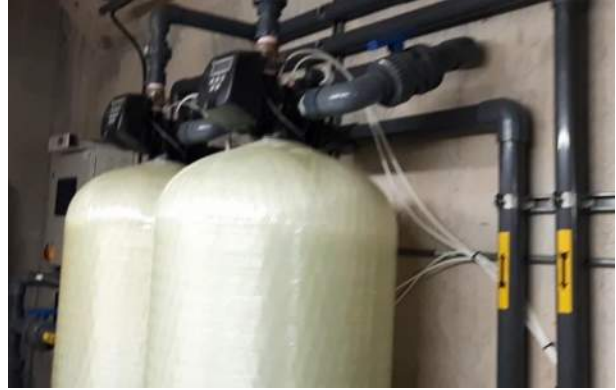
Figure 10 – Splash Pad Water Softeners

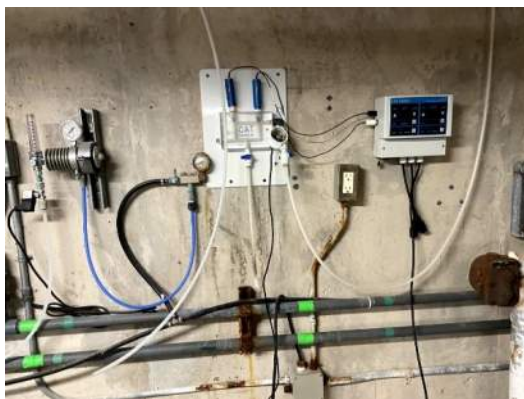
The amount of chlorine and CO₂ injected is based on the chemical levels in the water, being constantly monitored by the existing Hayward CAT-2000 chemical controllers for each pool system. Parameters are set within the chemical controller and probes monitor the chemical levels in the pool water. When the water balance falls outside those set parameters the dosing pumps will engage and inject the appropriate chemicals into the pool. The chemical controllers appeared to be in fair condition.

Figure 11 –Chemical Controllers

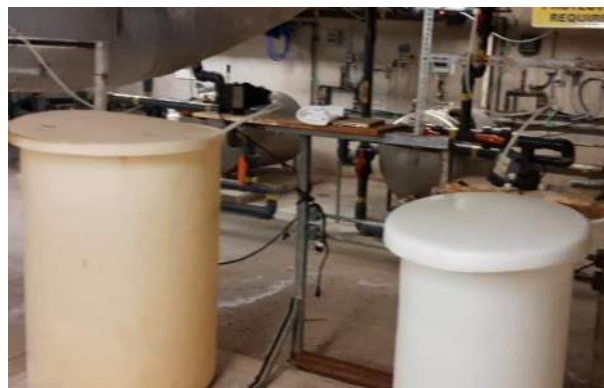
Figure 12 – Chlorine Storage Tanks

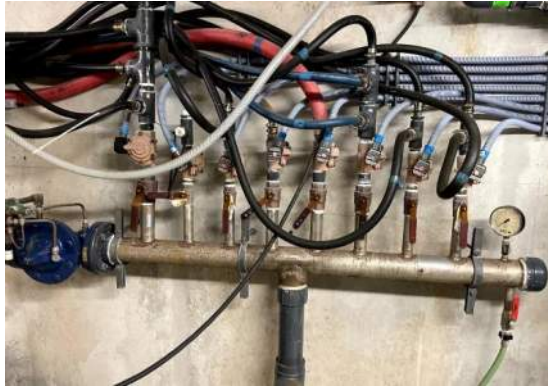
Significant rust and corrosion on some old valves and pipe hangers was observed. It is recommended that these corroded valves, pipe hangers and supports be replaced.

Figure 13 – Splash Pad Feature Return Piping

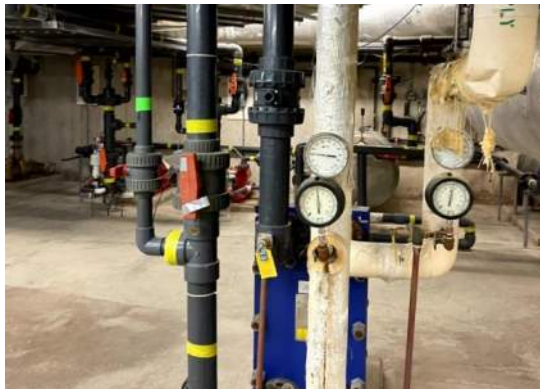
The Main Pool, as well as the Men and Womens' Whirlpools, are heated by existing plate heat exchangers for each pool, manufactured by Alfa Laval. The heat exchangers appear to be in moderate condition. The insulation on the heating-side piping to and from the heat exchangers is heavily damaged, appears to be falling apart. Further investigation of the internal elements by a mechanical consultant and contractor would be required to determine the overall condition and life expectancy of the heat exchangers, along with present efficiencies.

Figure 16 – Main Pool Heat Exchanger

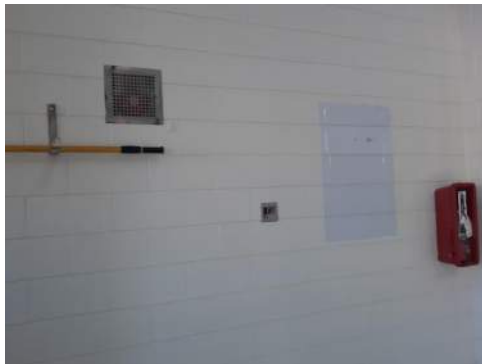
No emergency stop button or emergency telephone was found on the Main Pool deck. There are indications on the walls where pool safety signage appeared to have been posted, but seem to have been taken down with the closure of the facility. All of this is not in compliance with the requirements set by OBC 2012 and Reg. 565. All recirculating pumps in a public pool shall be capable of being deactivated by a common emergency stop button, clearly labelled with the appropriate signage as required by OBC 2012 and Reg. 565, located beside an emergency telephone on the pool deck, and be connected to an audible and visual alarm located by the emergency stop. For a Class A pool, an emergency telephone must be located adjacent to the emergency stop button on the pool deck. All pool notices and signage as required by OBC 2012 and Reg. 565 must be posted at suitable locations in the pool deck area before the pool is to be reopened.

Figure 17 – Main Pool Deck, Old Signage Location
