CITY OF ST. CATHARINES

ST. CATHARINES YMCA BUILDING CONDITION ASSESSMENT & STUDIES

JULY 24, 2024

PROJECT NO.: CA0036719.6657
DATE: JULY 30, 2024

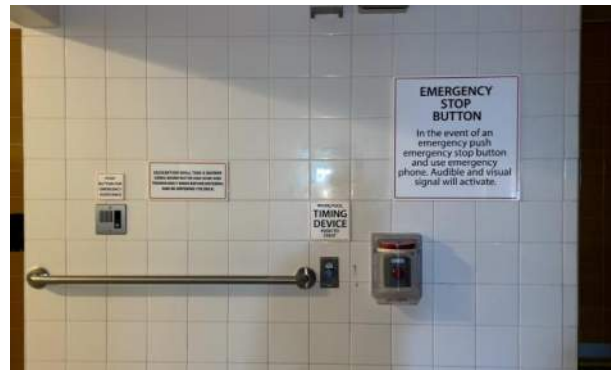
Each of the Men and Womens' Whirlpools have existing emergency stop buttons complete with audible and visual alarms. Emergency stop button signage was found at the Womens' Whirlpool on the ground floor, but not at the Mens' Whirlpool on the second floor. For Public Spas, an emergency telephone must be located within 30 meters of the spa. All pool notices and signage as required by OBC 2012 and Reg. 565 must be at appropriate locations at each Whirlpool, and there must be an emergency phone present within 30 meters of each Whirlpool before they are to be reopened.

Figure 18 – Womens' Whirlpool Signage

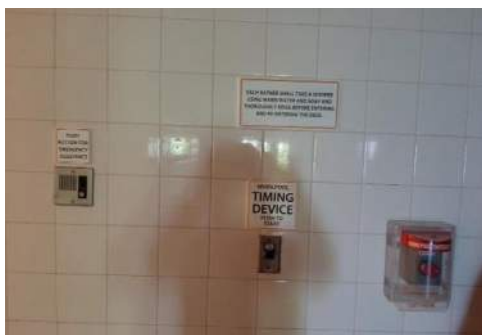
Figure 19 – Mens' Whirlpool Signage

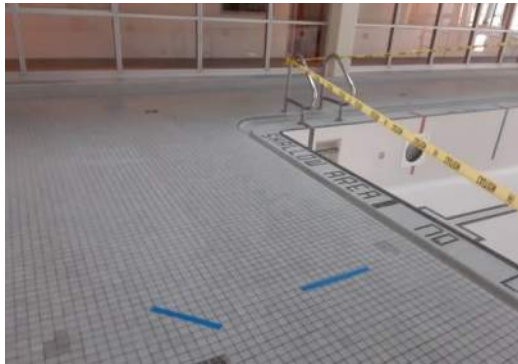
The Main Pool deck is finished with non-slip 2x2 tile that appears overall clean and in good condition on the surface. The deck is sloped towards area floor drains located around the perimeter of the pools, which appeared to be in good condition. A chain drag test performed on the deck tile has revealed that most of the tile has been debonded from the substrate, with one particular area of severe delamination at the area of the deck near the shallow end of the pool. It is recommended that the tile on the entire pool deck be removed and replaced completely using new mortar bed, membrane, and porcelain mosaic tiles. Depth markers were found to be installed, in contrasting tile along the pool gutter roll-out rim and comply with OBC 2012 requirements.

Figure 20 – Main Pool Deck, Marked Location of Severe Delamination

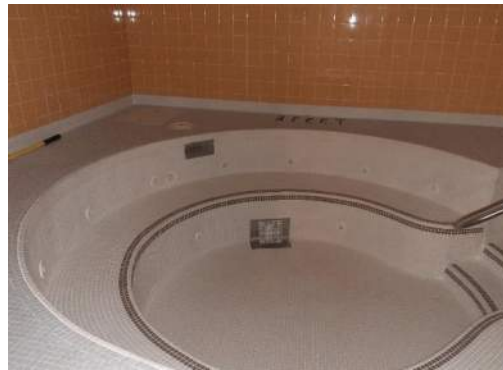
Depth markers in metric units were found to be installed on the main pool, in contrasting tile along the pool gutter roll-out rim and comply with OBC 2012 requirements. Depth markers in imperial units were found installed in contrasting tile along the elevated deck around each Whirlpool.

Figure 21 – Typical Whirlpool Deck and Tank

It is recommended that tactile walking surface indicator (TWSI) tiles be installed at the Main Pool and Whirlpool areas to warn users with visual impairment that they are approaching a hazard, as required by OBC 2012. The location and placement of the tactile indicator tile is to be reviewed with an Architectural Consultant based on upcoming revisions to the Ontario Building Code that related to this clause.

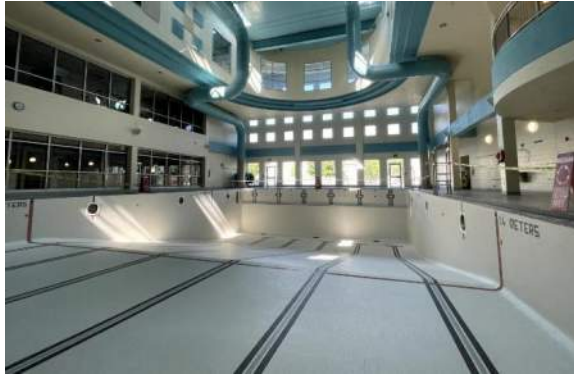
The Main Pool's tank interior is finished with 1" x 1" white mosaic tile throughout, and was found to be overall clean and in good condition on the surface. Racing lanes, end targets, and a diving board guide radius were observed to be present, tiled in a contrasting black, white, and grey pattern. There were no accent bands observed around the perimeter of the floor main drains, which is not in compliance with the requirements of OBC 2012. It is a requirement that a 2 inch wide (50mm) contrasting band will need to be installed around the main drains. It was observed that a 6 inch (150mm) black disc is present at the bottom of the deep end, which is in compliance with code. A chain drag test performed on the Main Pool tank tile has revealed that there were only one areas where the tiles were found to have been delaminated from the substrate, at the slope break point transition from the deep to shallow end. It is recommended that the tile in this area be removed and replaced.

Figure 22 – Main Pool Tank

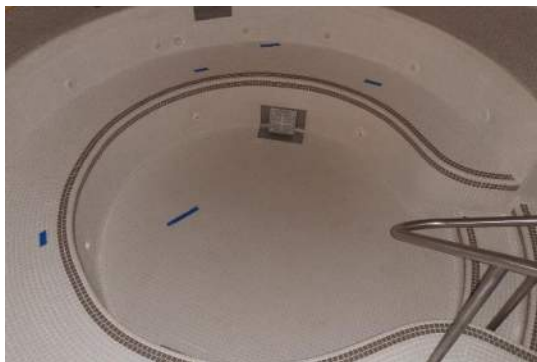
The Men and Womens' Whirlpool tank interiors are virtually identical, and are both finished with 1" x 1" white mosaic tile throughout. The tile finish was found to be overall clean and in good condition on the surface. Contrasting tile bands were found along the step and bench edges, however are not compliant with OBC 2012 requirements as the bands must be of contrasting color 50 mm wide along the entire juncture of the side and top of the edges. Around each main drain installed at the corner of the bench and floor is stainless steel plates that provide a contrast around the drain covers. No 6" (150mm) black disc was observed at the deepest point of either of the Whirlpools; it is recommended that this is installed at the Whirlpool floor. A chain drag test performed on both Whirlpools has revealed significant areas of delamination from the substrate; especially all along the benches and stairs. Based on discussion with operations staff, the Whirlpools have had a history of leaking. It is recommended that a static water test as well as a piping pressure test be performed on the Whirlpool tanks to establish that they are watertight. Afterwards, it is recommended that the tile finish for both Whirlpool tanks be removed and replaced completely using new mortar bed, membrane, and porcelain mosaic tiles, complete with all required accent bands and markings as per OBC 2012 and Reg. 565.

Figure 24 – Womens' Whirlpool Tank, Marked Locations of Tile Delamination

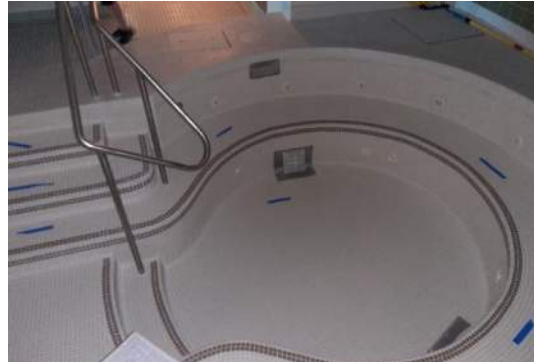
Figure 25 – Mens' Whirlpool Tank, Marked Locations of Tile Delamination

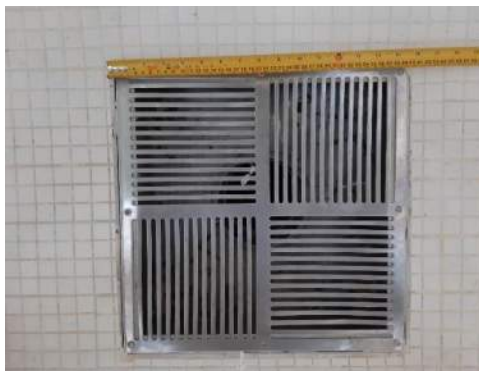
Both Men and Womens' Whirlpools contain two (2) 9" x 9" square main drains installed at the interface between the pool tank floor and bench. Based on the appearance of the main drain covers, the drains were found to be WG1031BHF2 model drains manufactured by Hayward, with an open area of 23.18 in² based on manufacturer information (0.015 m²). With the design flowrate of 140 US GPM plus an estimated 150 US GPM for the hydrotherapy jets, this results in a flow velocity of 1.22 m/s (4.0 ft/s), therefore the current main drain covers are not compliant with code requirements.

Figure 26 – Main Pool Main Drains

It is strongly recommended to install precautions where feasible to ensure safety of users and to prevent an entrapment hazard, as well as to comply with OBC 2012 and Reg. 565 requirements. At a minimum, this would include installing new main drain covers and/or sumps for the Main Pool and both Whirlpools, with a more open and "unblockable" area.

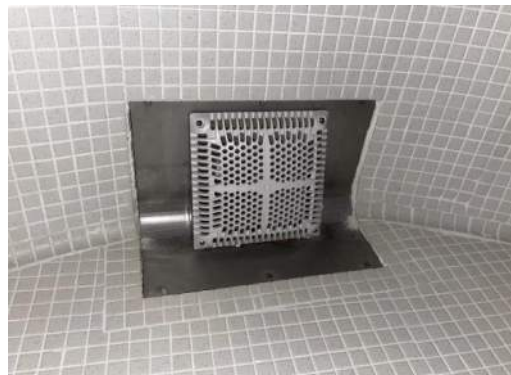
Figure 27 – Typical Whirlpool Main Drain

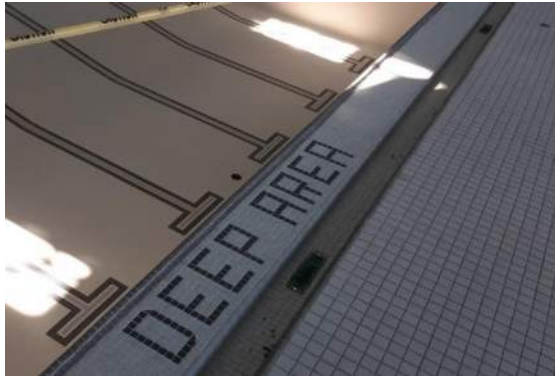
The Main Pool has a modified gutter system with twenty-four (24) bronze grilles with openings on the vertical faces of the pool roll out gutter rim. The grilles were all visibly corroded and tarnished with a blue-green layer of corrosion typical of bronze material. It is recommended all gutter grilles be ground polished, and refinished with a protective coating for restoration, or be replaced entirely with stainless steel grilles. Based on the design flowrate of 496 US GPM (80% of the total flow rate of 620 US GPM) the number of gutter drop fittings are sufficient; even if the Main Pool filtration system were upgraded and its flowrate increased.

Figure 28 – Main Pool Gutter Drop-outs

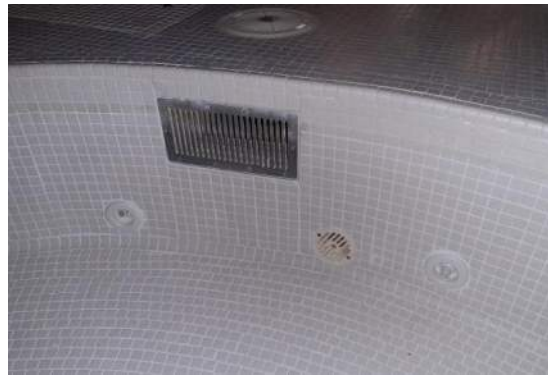
The Men and Womens' Whirlpools each have two existing skimmers installed to remove surface debris from the pool. Based on the design flow rate of 112 US GPM (80% of the total flow rate of 140 US GPM); this is not an adequate quantity for optimal circulation. In addition to the previous recommendation of replacing the existing skimmer suction piping, it is recommended that an additional skimmer be installed to

each Whirlpool to accommodate the existing flow rate. Stainless steel skimmer grilles were installed at the openings, and were found to be in good condition with minor staining.

Figure 29 –Typical Whirlpool Skimmers

8. Replace Men and Womens' Whirlpool skimmer suction piping to accommodate existing flowrate to meet OBC 2012 pipe velocity requirements, and install an additional skimmer to each Whirlpool.

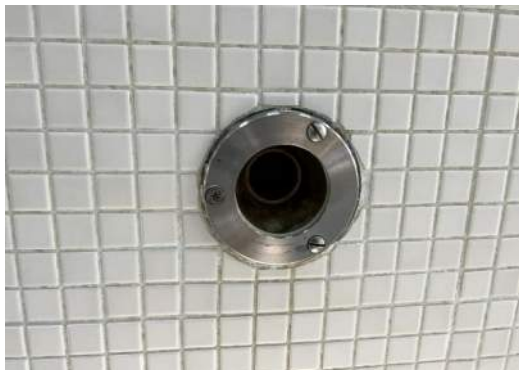
The Main Pool was found to have twenty (20) wall return inlet fittings around the perimeter of the pool. The wall return fittings are constructed of stainless steel with adjustable PVC eyeballs installed within and appeared to be in good condition, though some of the inlets were found to be missing the eyeball fittings. Based on the flowrate of 620 GPM, this number of inlets is not adequate to return water to the pool, which will be further be magnified if the flowrate were to be increased following an upgrade to the Main Pool filtration system. It is recommended that additional wall return fittings be installed in order to accommodate flowrate of the pool. Additionally, four (4) vacuum fittings were found to be installed along the perimeter of the pool as well. The vacuum fittings were plugged. It is recommended that these vacuum fittings be removed completely, along with all associated piping and equipment, as they are not permitted in Public Pools as per OBC 2012.

Figure 30 – Main Pool Return Fitting, Missing Eyeball

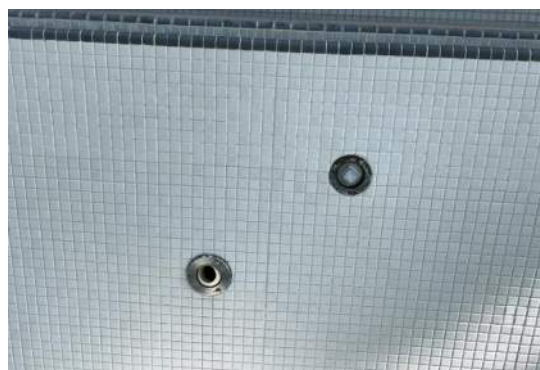
Figure 31 – Main Pool Return and Vacuum Fitting

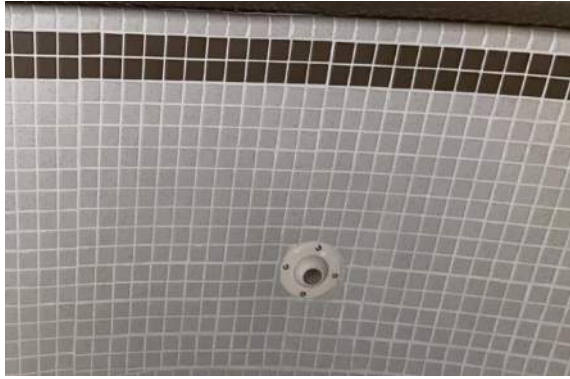
The Men and Womens' Whirlpools were both found to have four (4) wall return inlet fittings along the lower bench face. The wall return fittings are of PVC construction with adjustable eyeballs installed and appeared to be in good condition. Based on the flowrate of 140 GPM, this number of inlets is not adequate to return water to the Whirlpools. It is recommended that additional wall return fittings be installed in order to accommodate flowrate of the whirlpools. Additionally Ten (10) hydrotherapy jet fittings are installed along the upper bench faces, and appeared to be in good condition. Skimmer equalizer and vacuum fittings were observed to be installed on the Whirlpools. It is recommended that these vacuum and equalizer fittings be removed completely, as they are not permitted in Public Pools as per OBC 2012.

Figure 32 – Typical Whirlpool Return Fitting

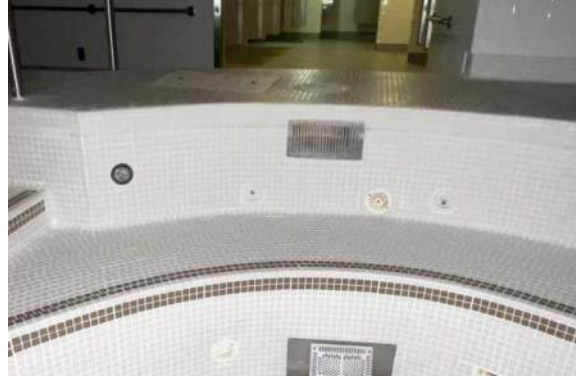
Figure 33 – Typical Whirlpool Vacuum, Equalizer, Hydrojet Fittings

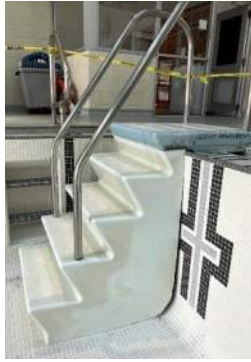
Figure 35 – Main Pool Accessibility Steps

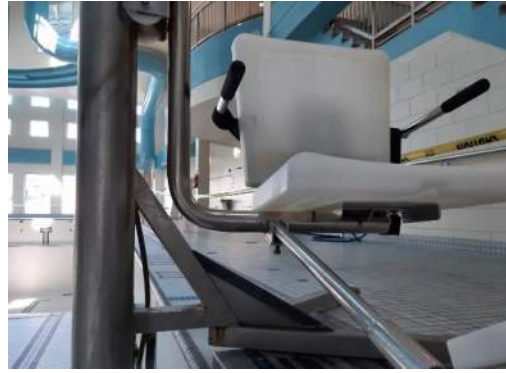
Figure 36 – Main Pool Accessibility Lift

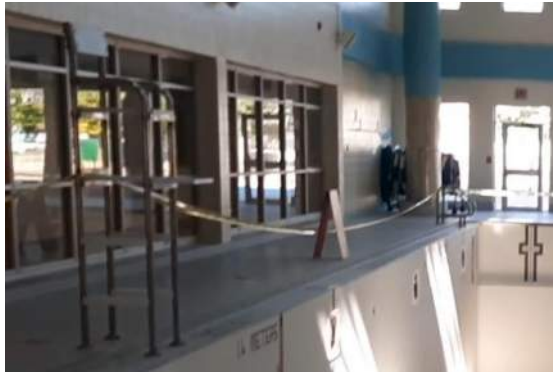
Figure 37 – Main Pool Lifeguard Chair

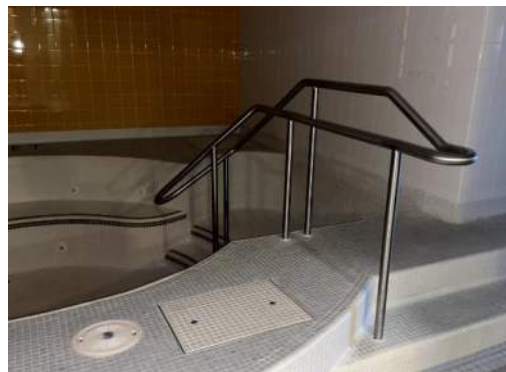
The Men and Womens' Whirlpools both have one (1) set of stainless-steel handrails located along the entry stairs to the whirlpools. The handrails were in overall fair condition.

Figure 38 – Typical Whirlpool Handrails

Overall, it is recommended that all stainless-steel components and accessories on the pool deck be polished and cleaned to remove signs of staining, corrosion, and discolouration.

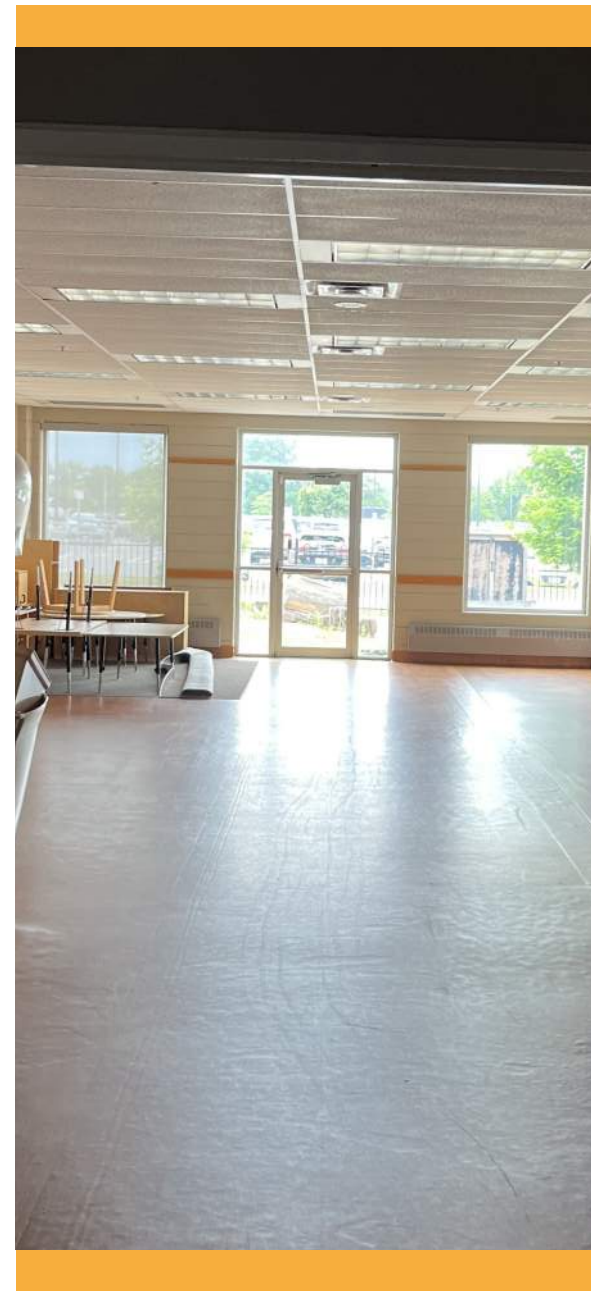
Example 2

**Example 2**
 Wood look sheet floor in Gross Motor Room is bubbling at doors and is a trip hazard.
Possible resolution: Replace flooring.

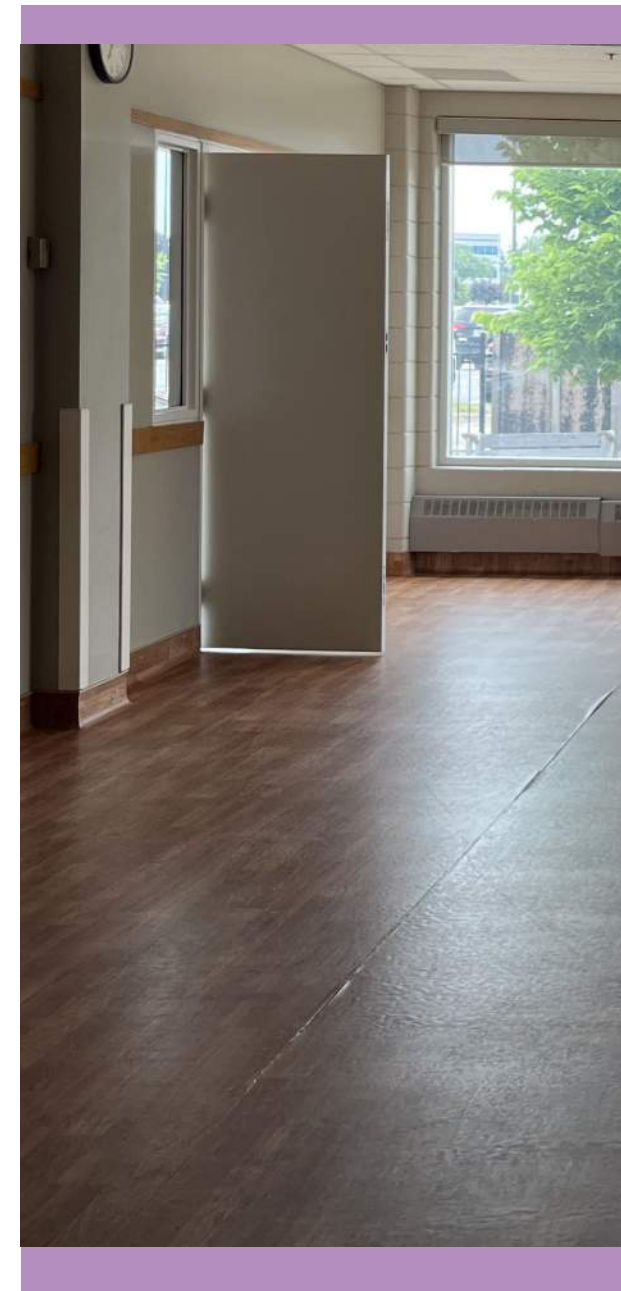
Example 3

**Example 3**
 Some seams appear to be lifting in Playrooms.
Possible resolution: Replace flooring.

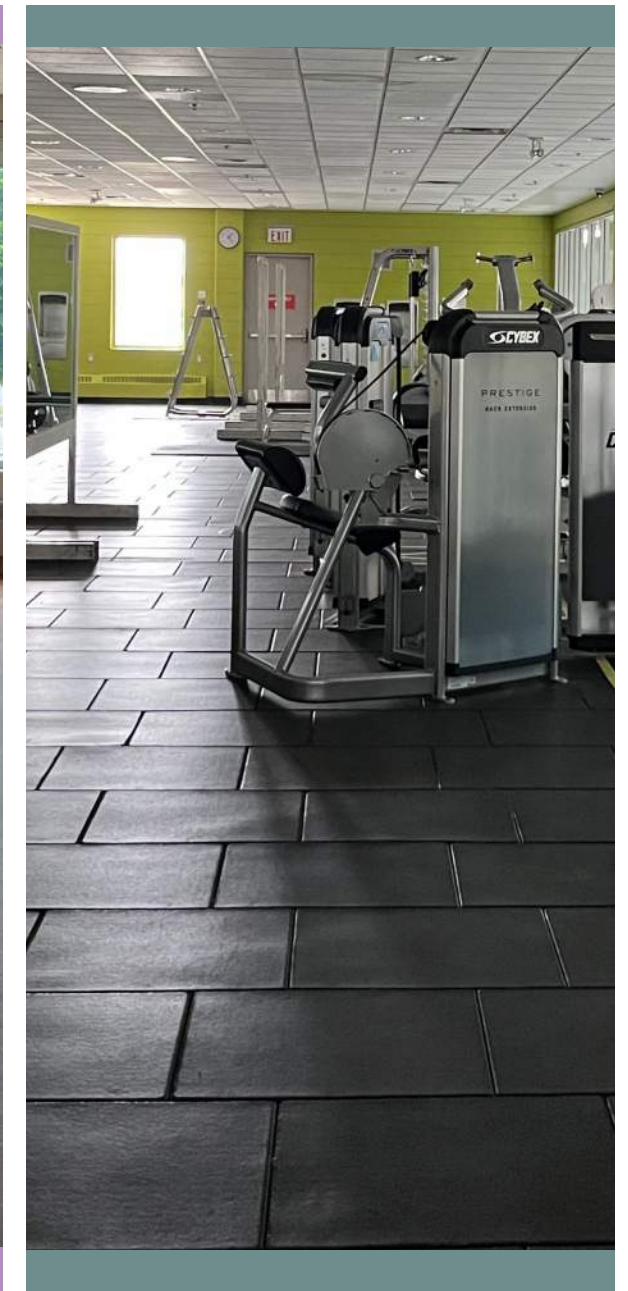
Example 4

**Example 4**
 Free Weight Exercise Area has a resilient tile floor with pronounced seams that appear lifting and present a possible trip hazard.
Possible resolution: Replace flooring.

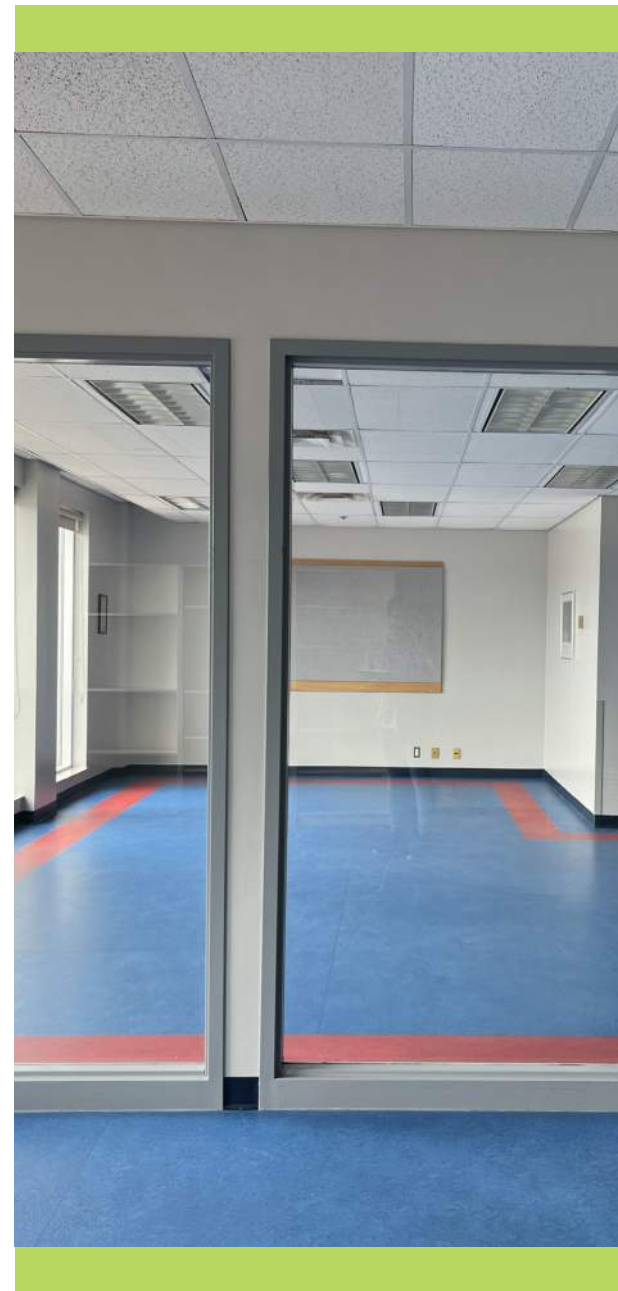
4.1.8 Windows, Glazed Screens and Sidelights

There is fluted glass in Level 1 administrative area without decals.

Possible resolution: Add vision strips or decals to glazing.

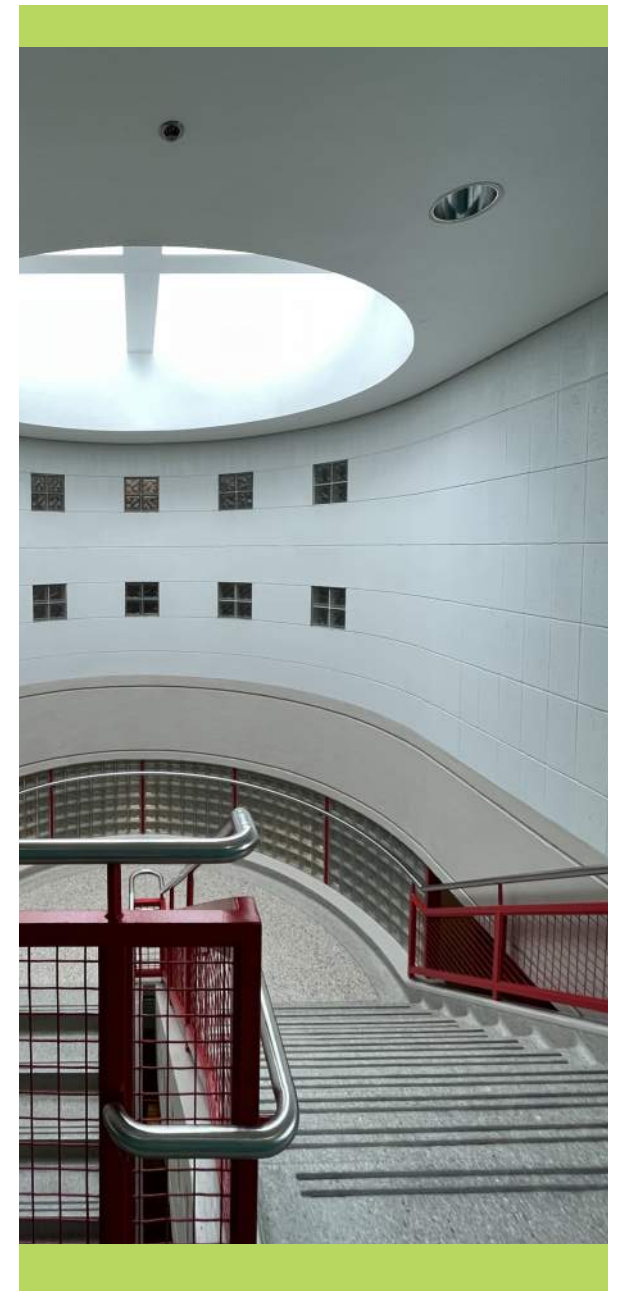
4.1.11 Stairs

No detectable warning surface at top, bottom or landings of stairs but appears tactile nosing is added on the top step.

Possible resolution: *Install tactile warning area where required.*

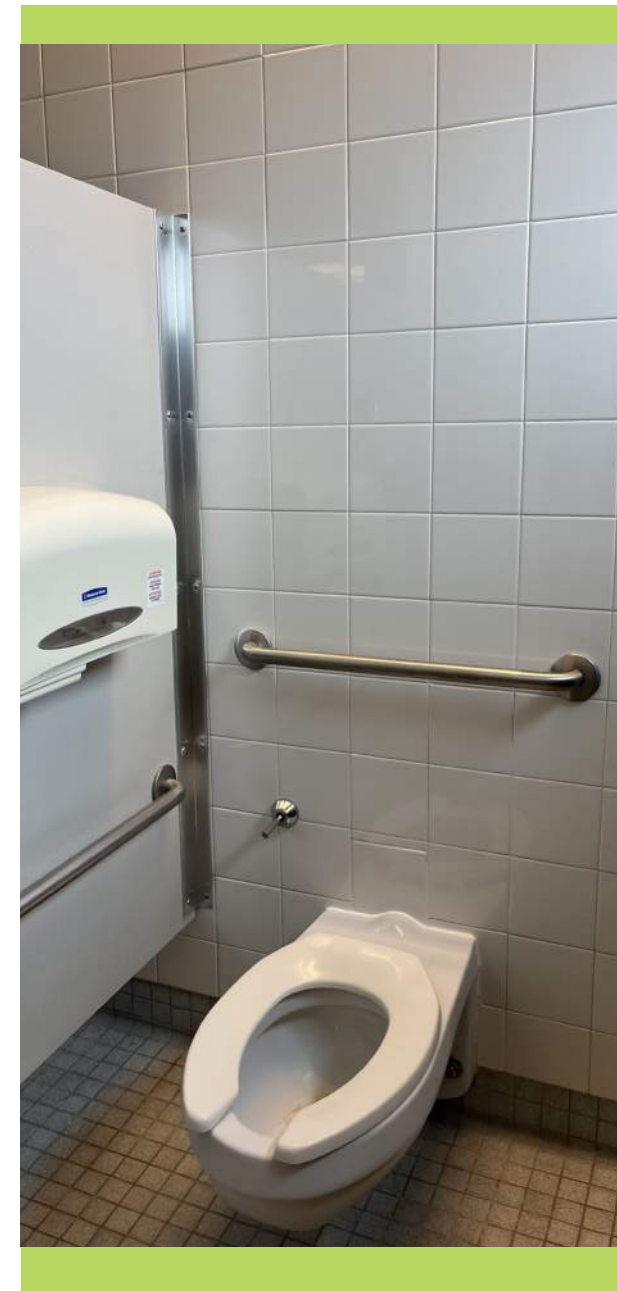
4.2.2 Toilet Stalls

D-type pulls are present on some stalls, but pulls missing from others.

Possible resolution: Install required D-type pulls. Paint existing stalls or replace with new to meet contrast levels.

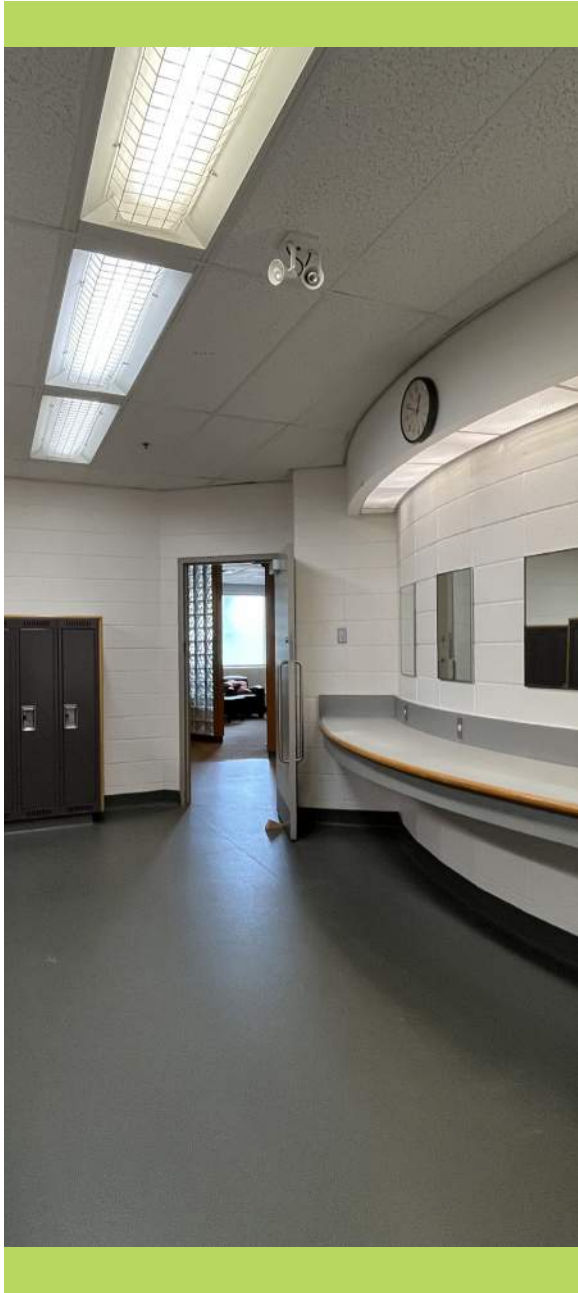
4.3.4 Change/Dressing Rooms

Mirrors are not full height but are standard 610 x 915 mm above convenience countertops.

Possible resolution: Add full height mirrors.

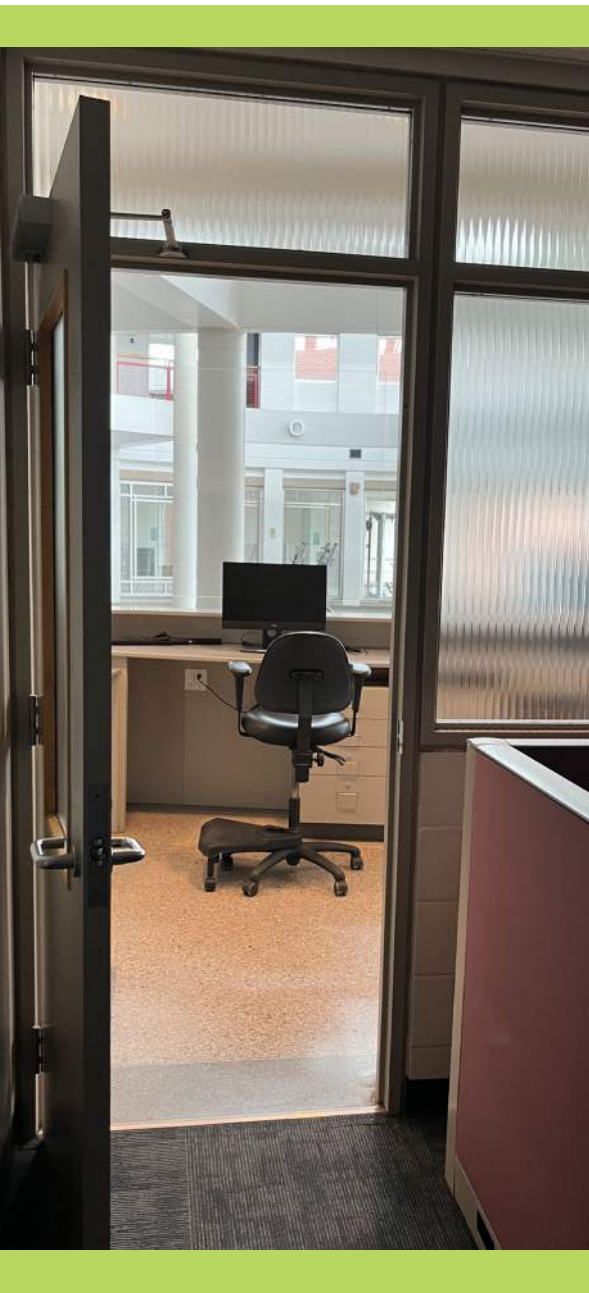
4.3.5 Offices, Work Areas and Meeting Rooms

Appears to comply with access route requirements however upper storage is mounted higher than accessible requirements.
Possible resolution: Add storage within accessible heights or lower existing storage to meet requirements.

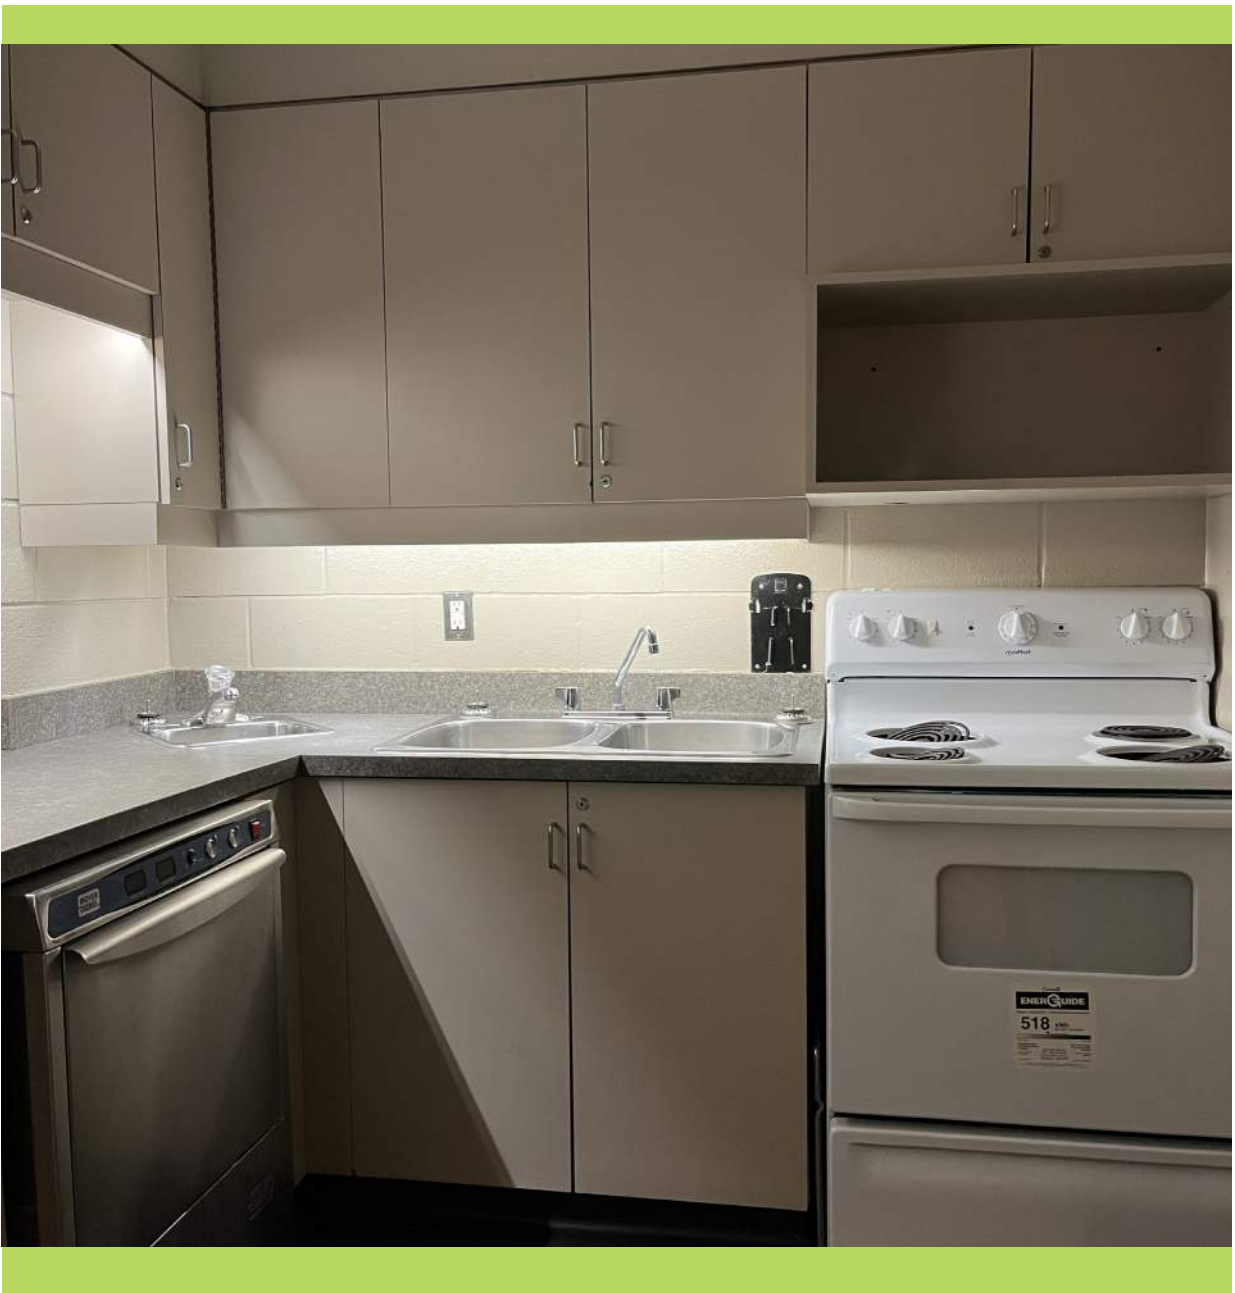
4.3.18 Kitchens and Kitchenettes

Cabinets are too close in colour to walls in the Servery.

Possible resolution: *Replace millwork and appliances accordingly.*

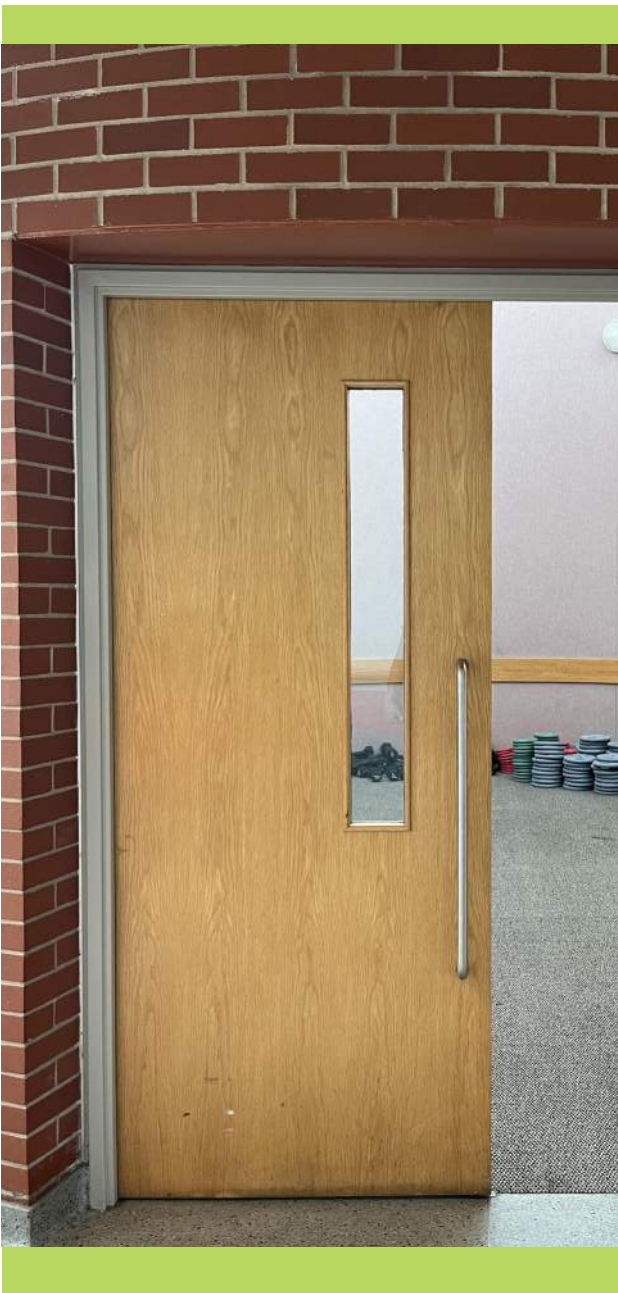
4.4.15 Texture and Colour

Most walls appear to be white.

Possible resolution: *Paint walls accordingly.*

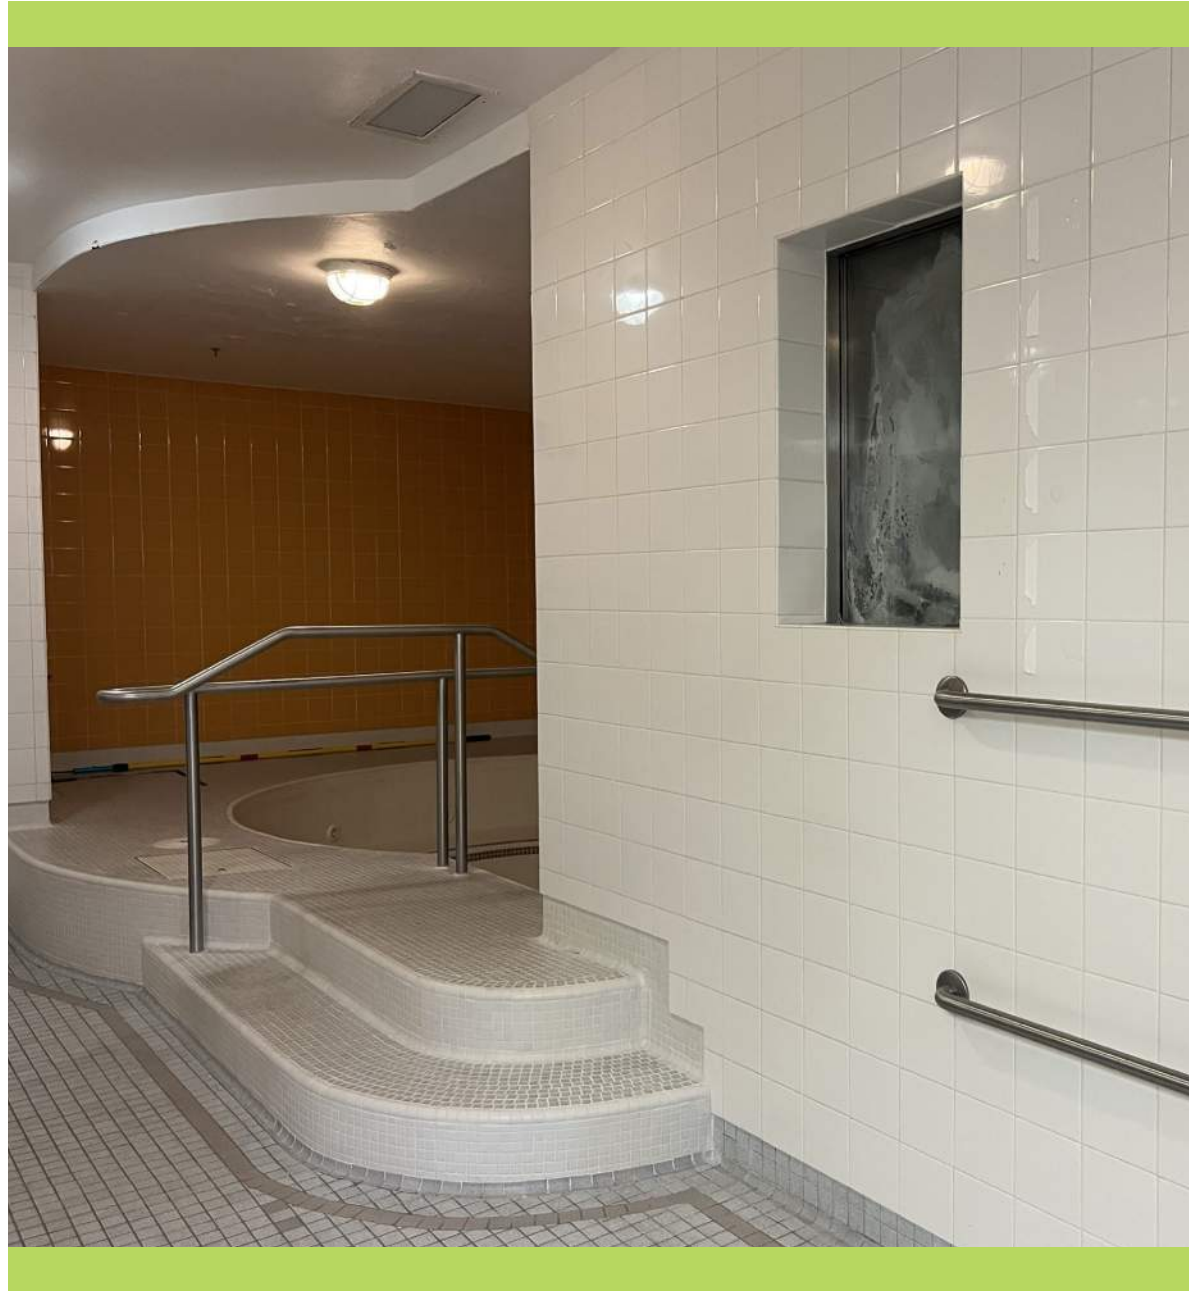
4.5.3 Swimming Pools, Therapeutic Pools/Public Spas and Spray Pads

There is no apparent transfer wall, but there are adjacent walls with horizontal grab bars at 2 heights leading to the spa, with room for a mobility device.

Possible resolution: Add grab bar perpendicular to spa as per heights above. Ensure adequate clear space on deck.

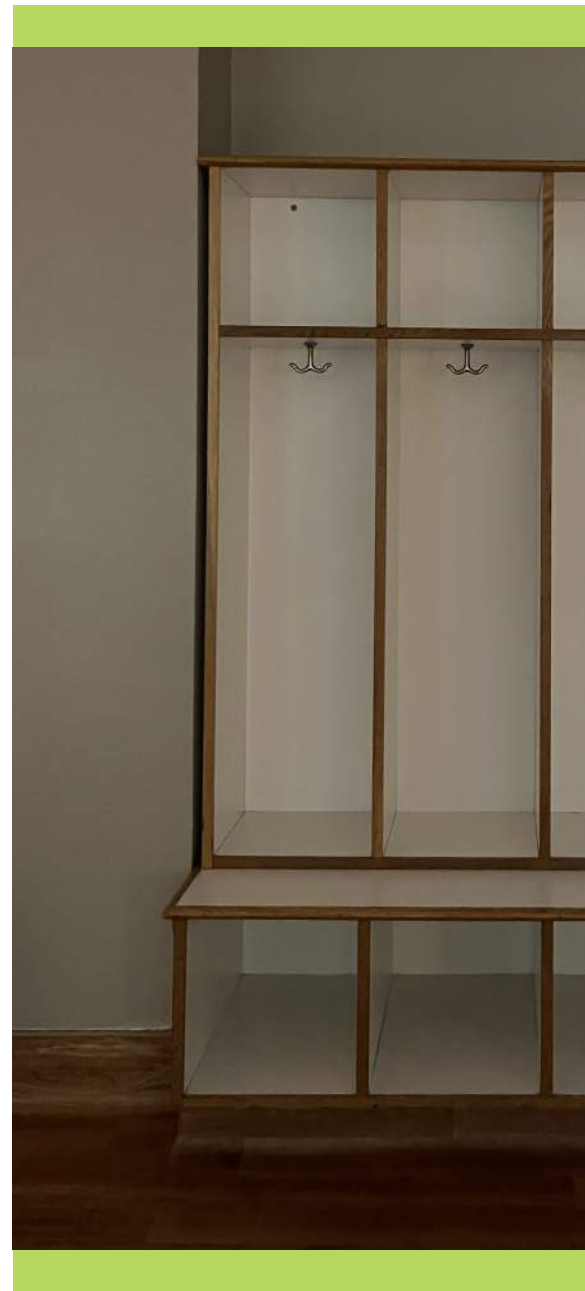
4.5.14 Child Care/Minding

Coat hooks are non-collapsible and are above benches.

Possible resolution: *Install non-collapsible coat hooks adjacent to benches.*

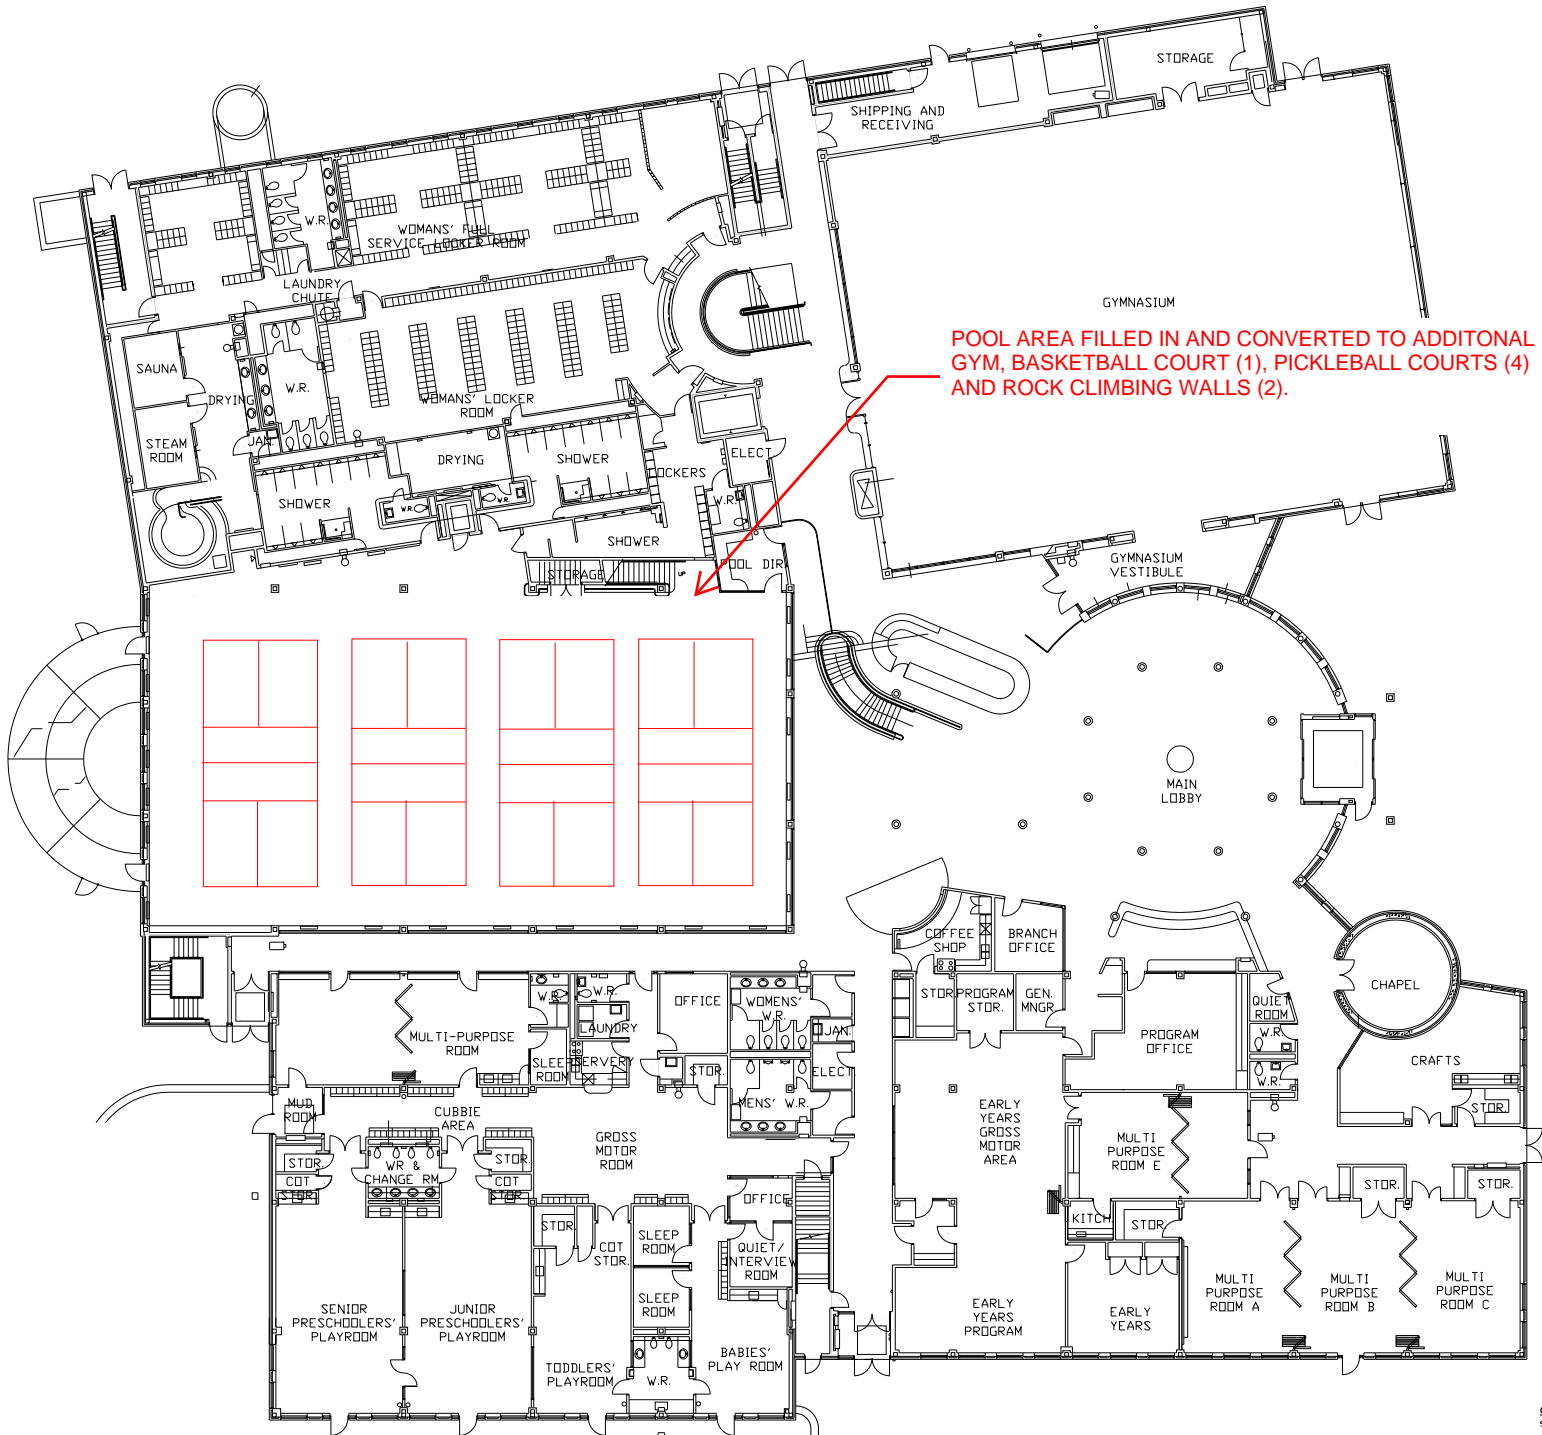
ALTERNATIVE USES: GROUND FLOOR OPTION 1

POOL AREA FILLED IN AND CONVERTED TO ADDITIONAL GYM, BASKETBALL COURT (1), PICKLEBALL COURTS (4) AND ROCK CLIMBING WALLS (2).

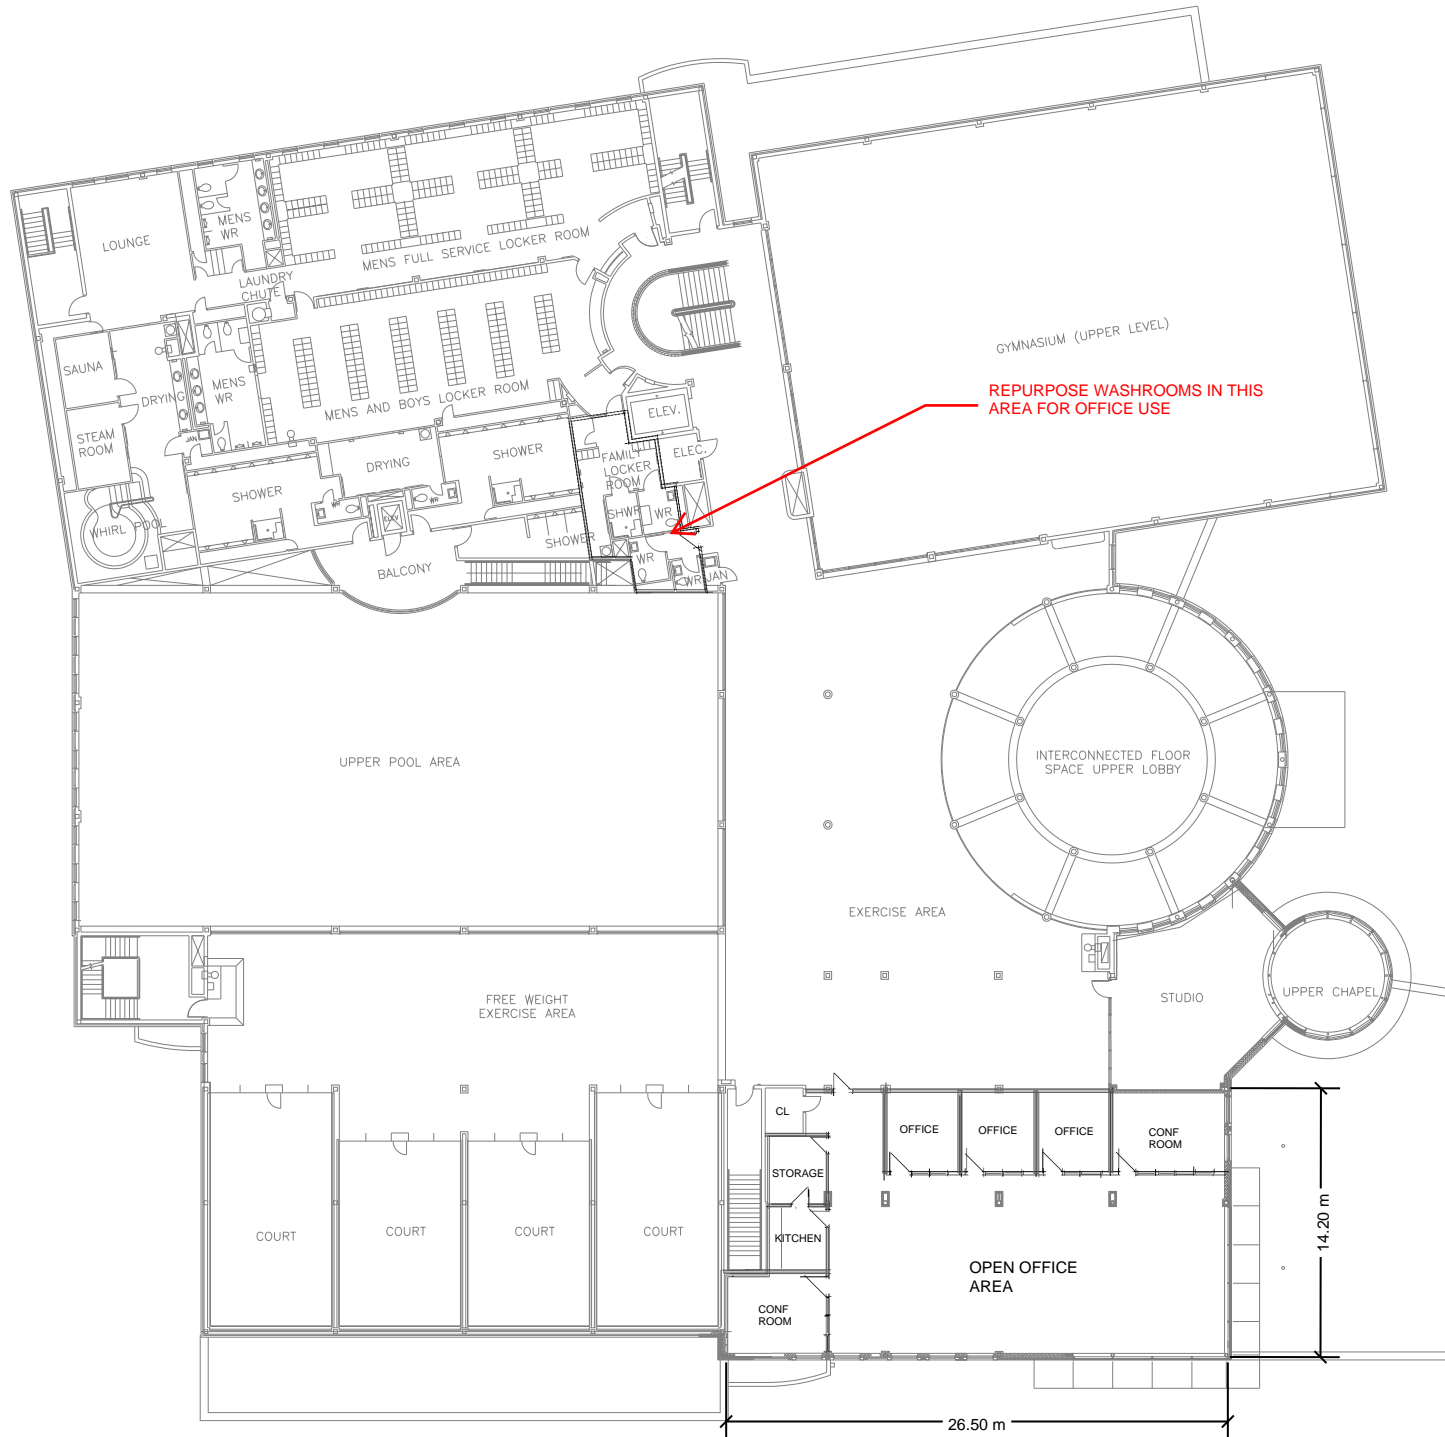
ALTERNATIVE USES: SECOND FLOOR OPTION 2

REPURPOSE WASHROOMS IN THIS AREA FOR OFFICE USE
