CITY OF ST. CATHARINES

ST. CATHARINES YMCA BUILDING CONDITION ASSESSMENT & STUDIES

JULY 24, 2024

PROJECT NO.: CA0036719.6657
DATE: JULY 30, 2024

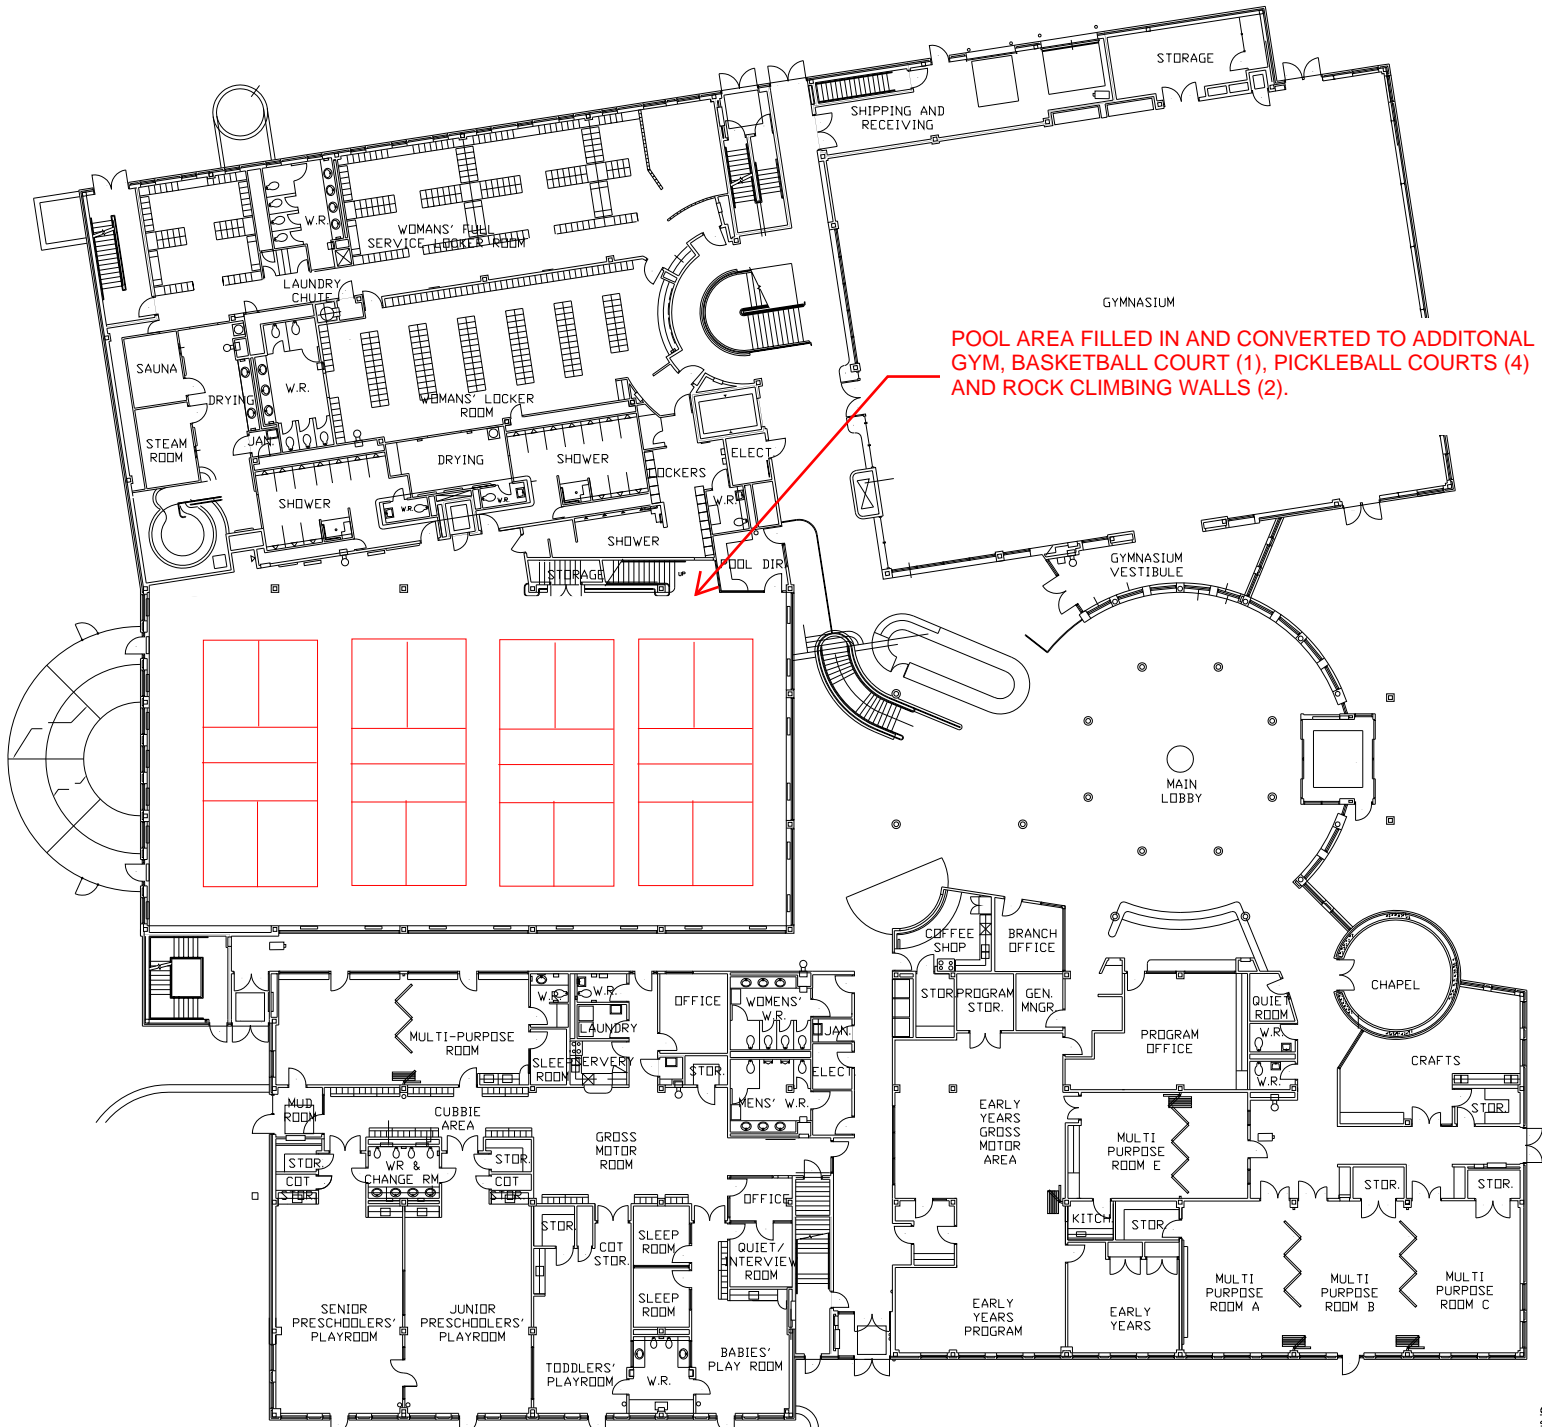
ALTERNATIVE USES: GROUND FLOOR OPTION 4

POOL AREA FILLED IN AND CONVERTED TO ADDITIONAL GYM, BASKETBALL COURT (1), PICKLEBALL COURTS (4) AND ROCK CLIMBING WALLS (2).
